**RE: BBV LAKES & POND ALGAE, CURRENT CONDITIONS**

This is the first report for the 2026 season, with photos and notes on four different water bodies being taken. These include **Thunderbird Lake** SE corner, **Kwann Lake** [NE corner + SE corner] the **South Golf Course Pond #5**, and the **North Golf Course Pond #1**. When available we also include photos and notes from the other (mid-course) golf course ponds # 2,3 and 4.

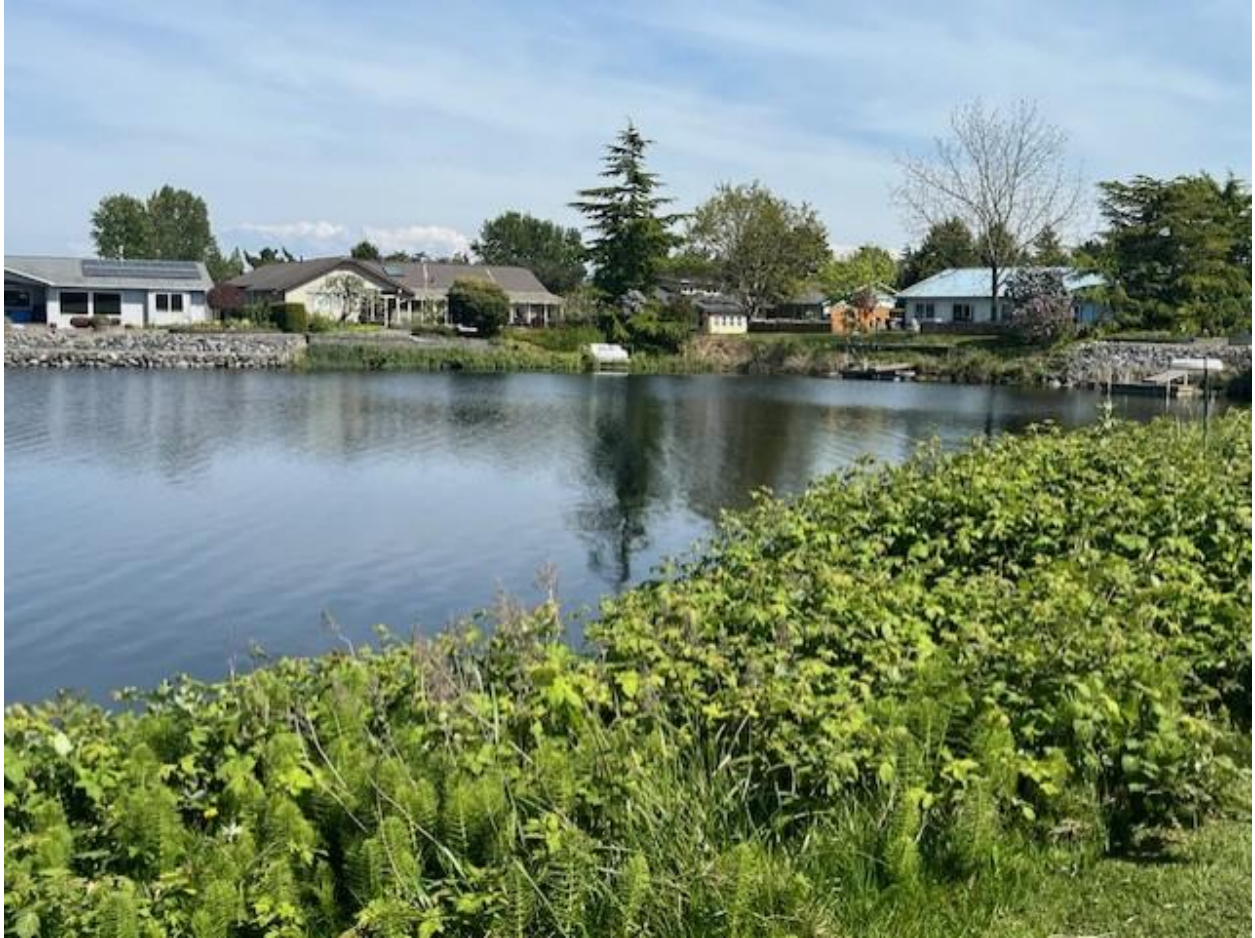
1. **SE Corner of Thunderbird Lake**, 5/01/26. Thunderbird Lake generally very clean and clear. The lake is essentially devoid of filamentous algae as seen from this viewing location.

Shoreline plant growth (including blackberry bushes) along the southern edge (boat launch side) is abundant.

<b>LOCATION: PHOTOS TAKEN ON 5/01/26</b>	<b>IS ANY SURFACE ALGAE PRESENT NOW?</b>	<b>DESCRIPTION OF CURRENT CONDITIONS</b>
1. Thunderbird Lake, SE corner near boat launch	NO	No signs of filamentous algae on the surface of the lake that is visible from this point at this time.

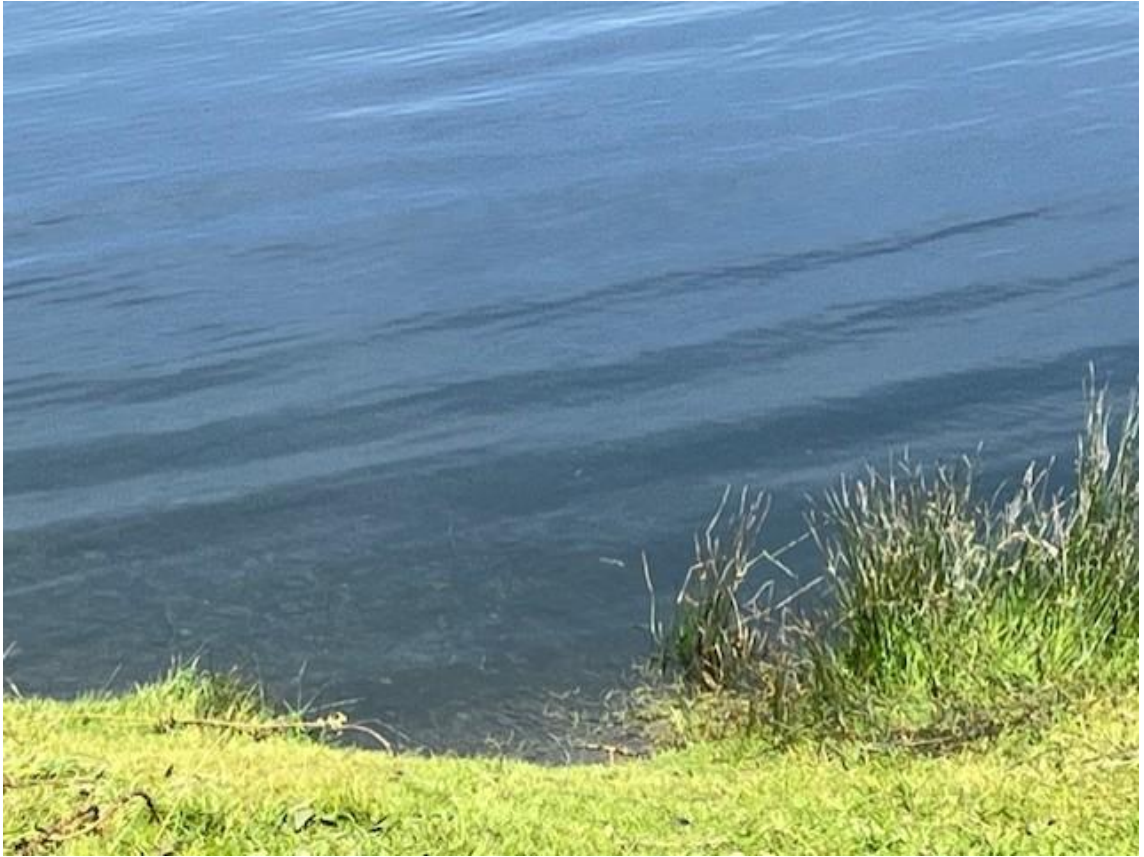
Closeup at this observation point on Thunderbird Lake shows a nearly-barren bottom with little to no signs of aquatic plant growth.

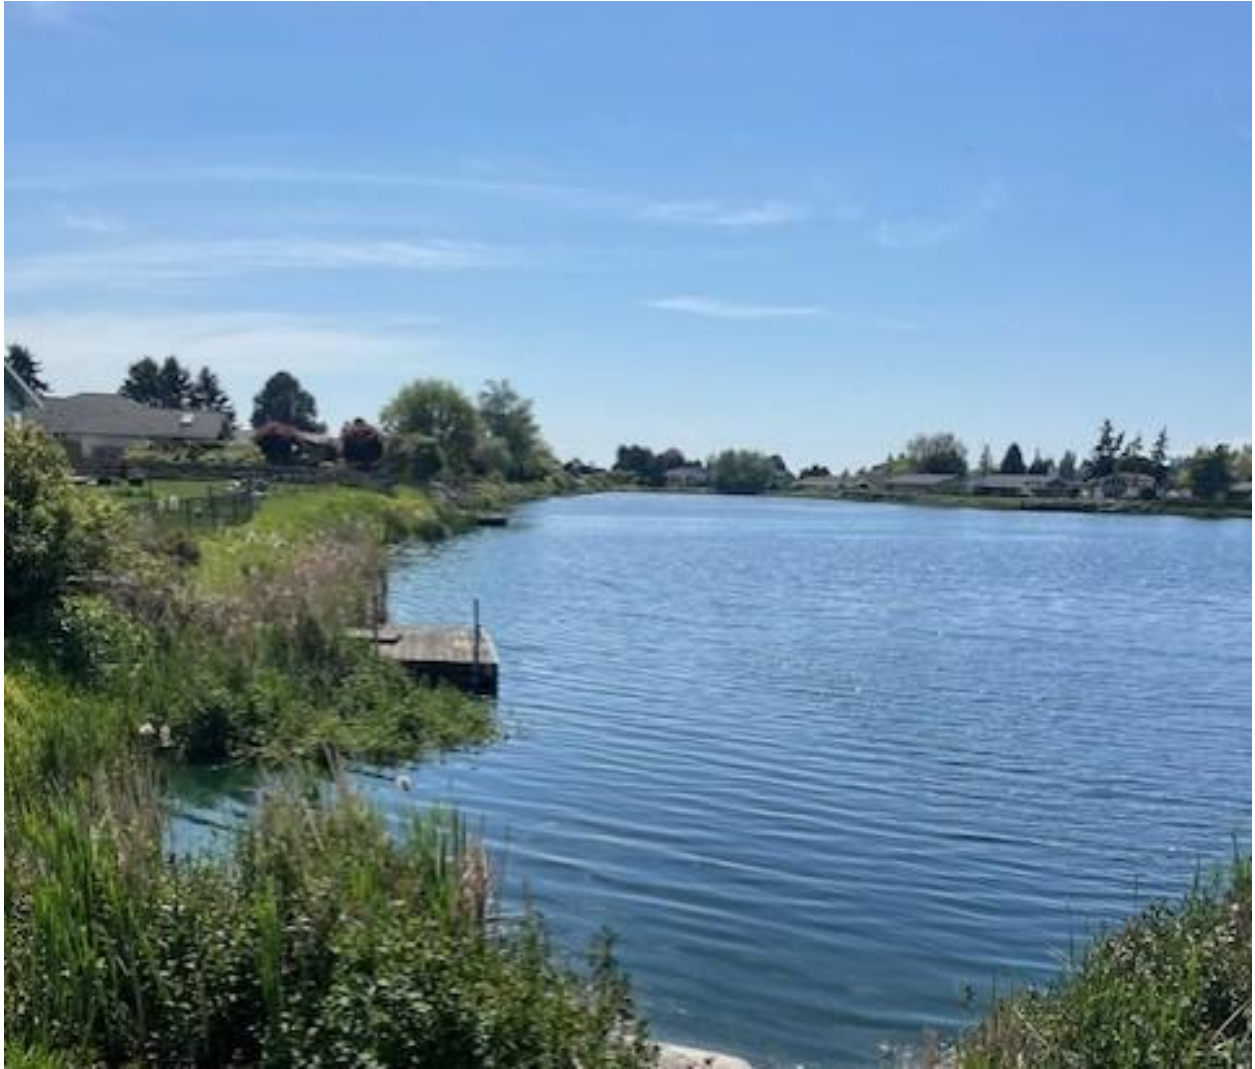
2. **NE Corner of Kwann Lake, 5/01/26.** No sign of any algae on the surface or along the edge here.

Abundant patches of nightshade are appearing, along with the usual/typical blackberry bushes down to the water's edge.

2. Kwann Lake, NE corner near the blocked culvert	NO	No signs of any type of algae are visible on the surface at present.
2a. Kwann Lake, SE corner near launch	NO	No visible surface algae of any type here.

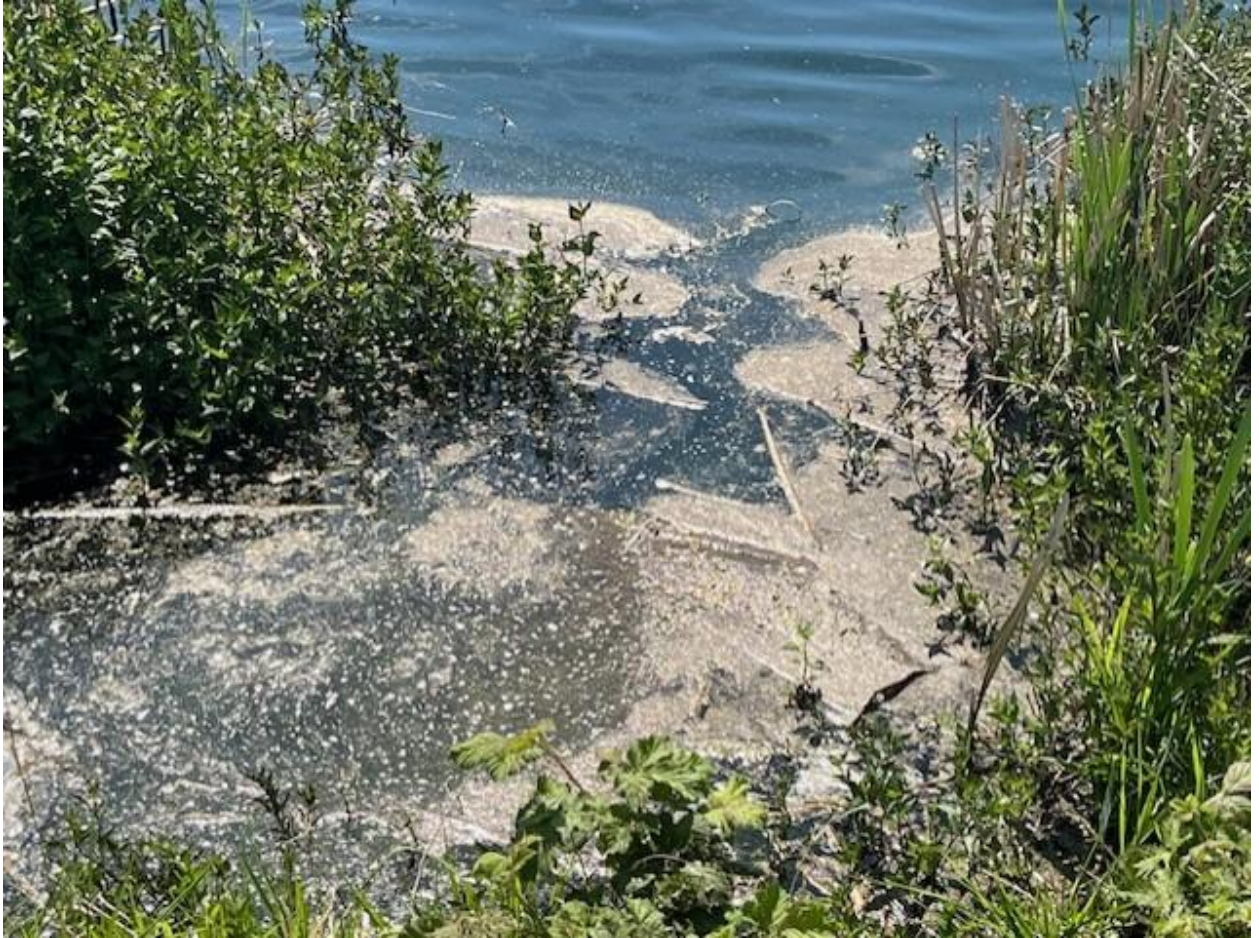
A closeup of this northeast corner of Kwann Lake shows the first seasonal beginnings of some material floating on the surface. It is a mix of floating dead leaves, pollen, feathers and trimmed plant remnants that combine to form surface scum often observed here.

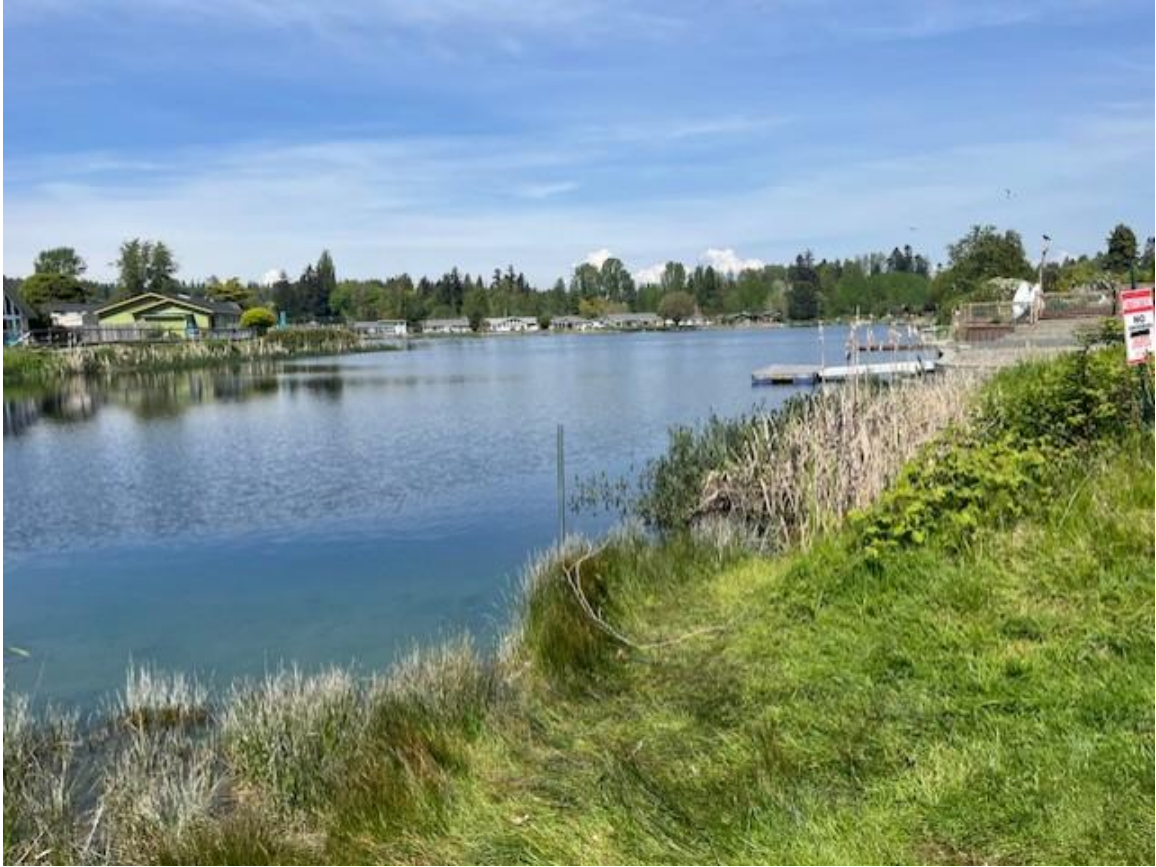
2a. **SE corner of Kwann Lake near boat launch.** 5/01/26. No signs of blue-green algae (or any other type of algae) present on the surface at this location. The lake as viewed here is generally clean and clear.

The mild bluish coloration of the water is due to the recent application of AquaShade UV blocker.

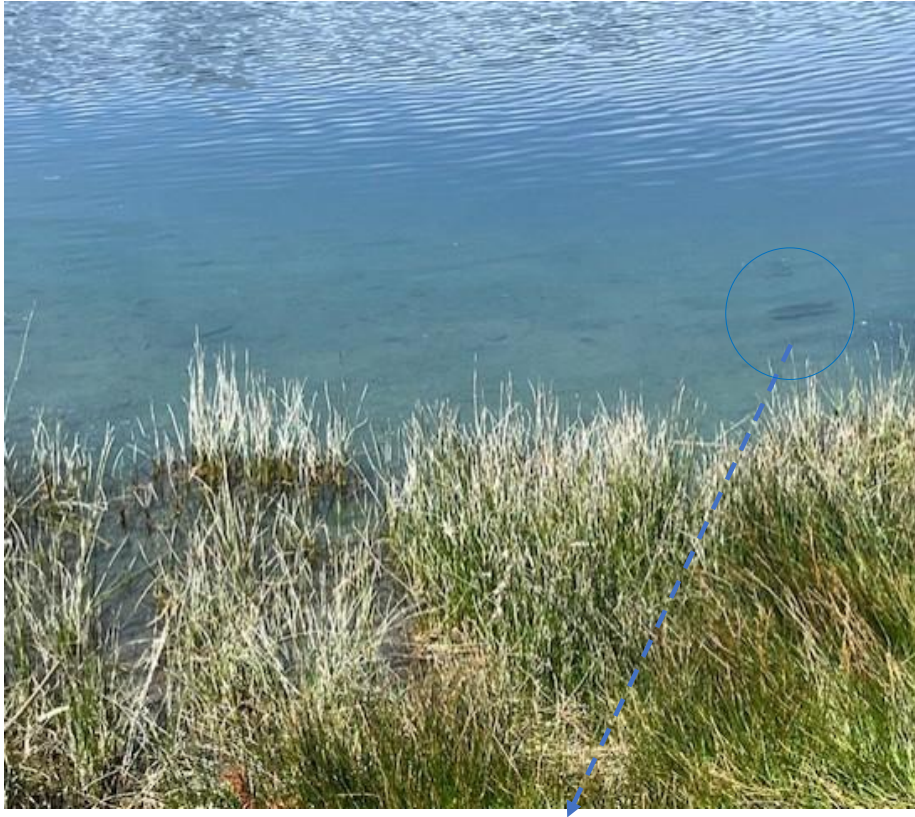
( 2a cont'd.) Closeup of the SE corner of the Kwann Lake (boat launch site). Note the clean, clear bottom at this location. No signs yet of aquatic plant or bottom-growing algae buildup at the start of this season.

Sedge-type shoreline grasses are growing along the water's edge at this spot.

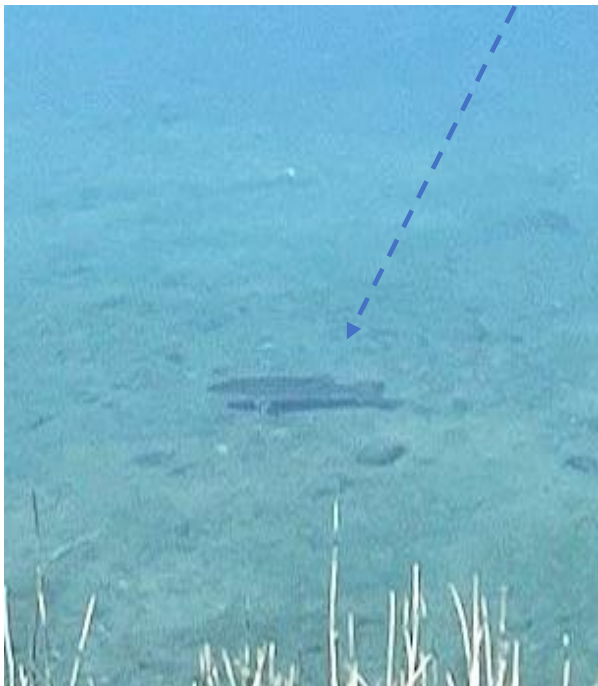
*BONUS CLOSEUP PHOTO:  
≈ 12" fish (likely a bass)  
enjoying the warm,  
shallow water at this spot*

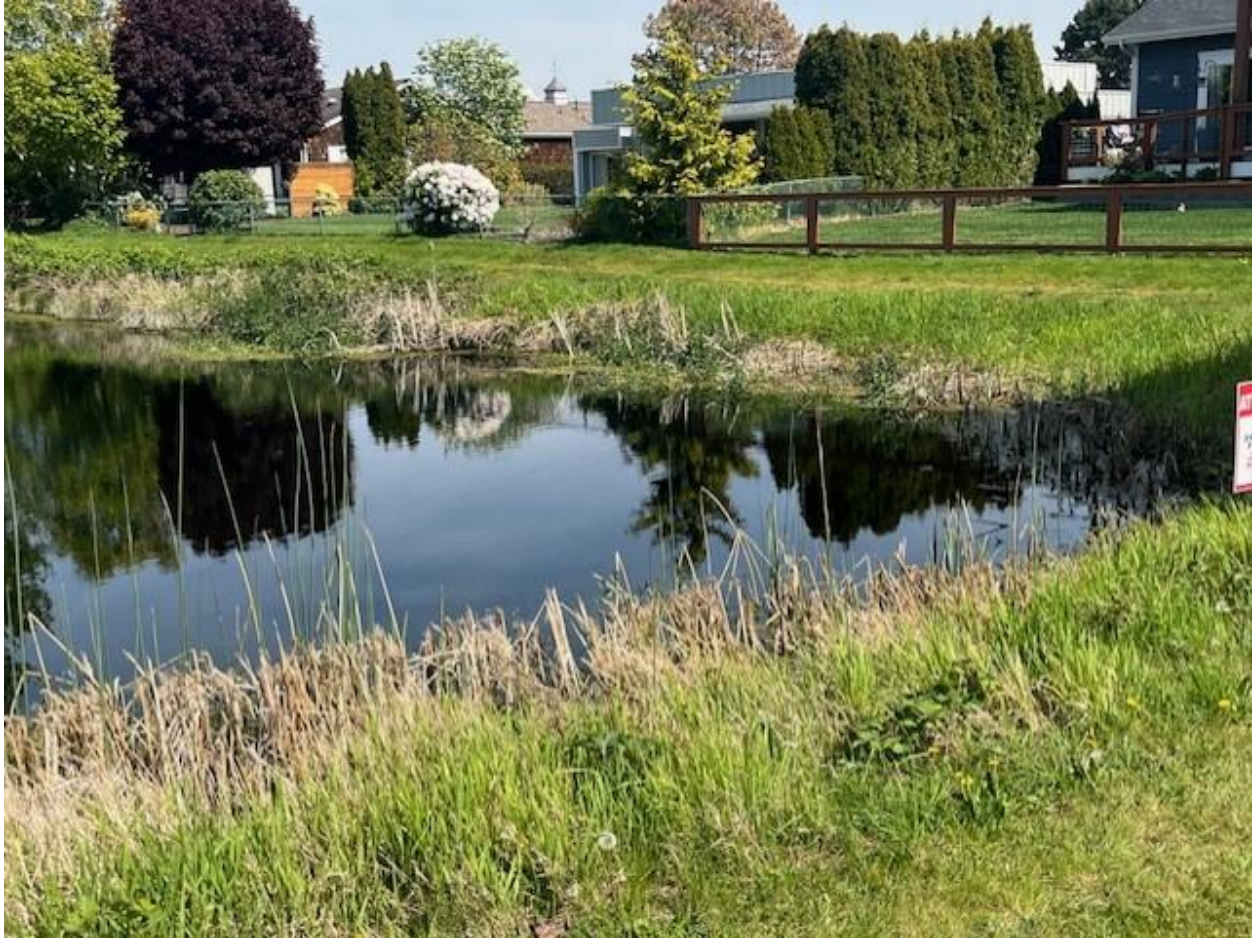
3. **South Golf Course Pond** – 5/01/26. Clear water with a nearly algae-free surface. The filamentous algae that occurs at this south end of the pond, along both the east and west edges, is present here once again. Shoreline plant growth (cattails, canary grass) has been recently trimmed.

3. South Golf Course Pond (#5), viewed from the road	YES, very minor	Small amount of filamentous algae visible on the eastern edge, which has been a constant for the past couple of years. Minor amount also seen amongst the cat-tails at the western edge of this corner of the pond.

BBV's primary water bodies are starting this season almost entirely free of surface-level algae. Only the south golf course pond (#5) has some minor signs of filamentous algae mats starting to appear on the water surface, along the edges at the south end in the usual locations.

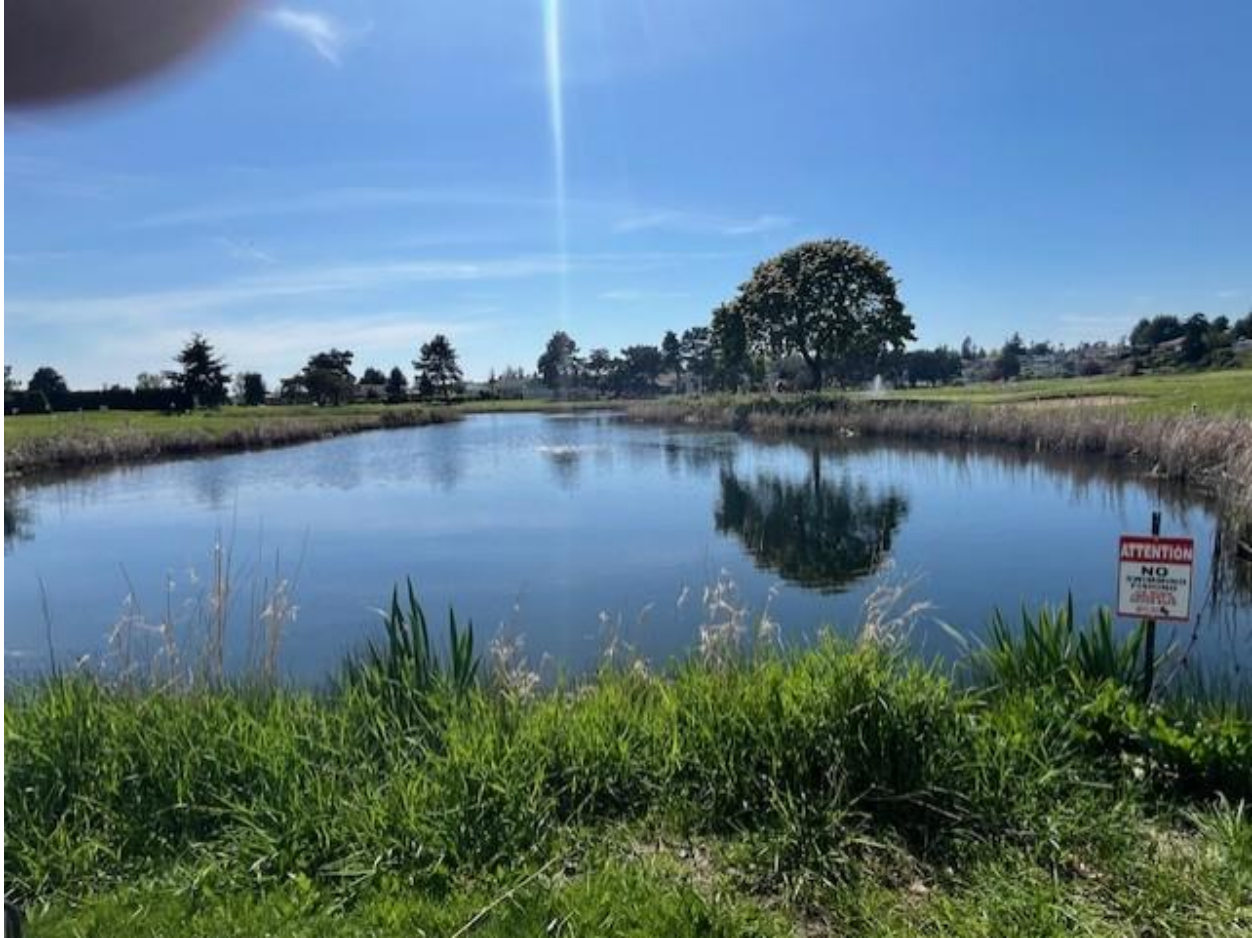
4. **North Golf Course Pond** - 5/01/26. Surface condition: practically no visible plant matter on the water or along the shoreline. Exceptionally clear of surface plant material, compared to last season.

4. North Golf Course Pond (#1), viewed from east shoreline	NO	No patches of filamentous algae mats present at the southeastern corner/edge; this location typically had algae here all of last season. Some pond scum buildup.

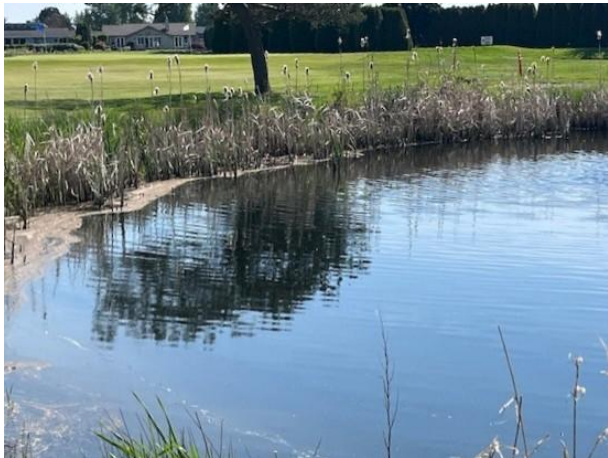
East edge, south side, some pond scum present

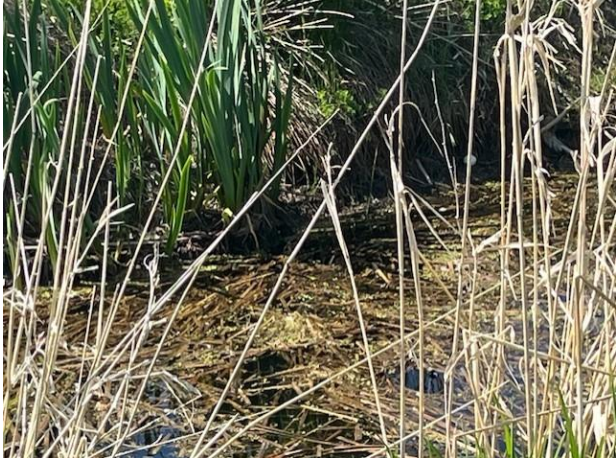
Far N.E. corner (near culvert): some plant trimmings
