To: BBV Lakes, Ponds & Drainage Committee

JUNE REPORT 6/1/26

RE: BBV LAKES & POND ALGAE, CURRENT CONDITIONS

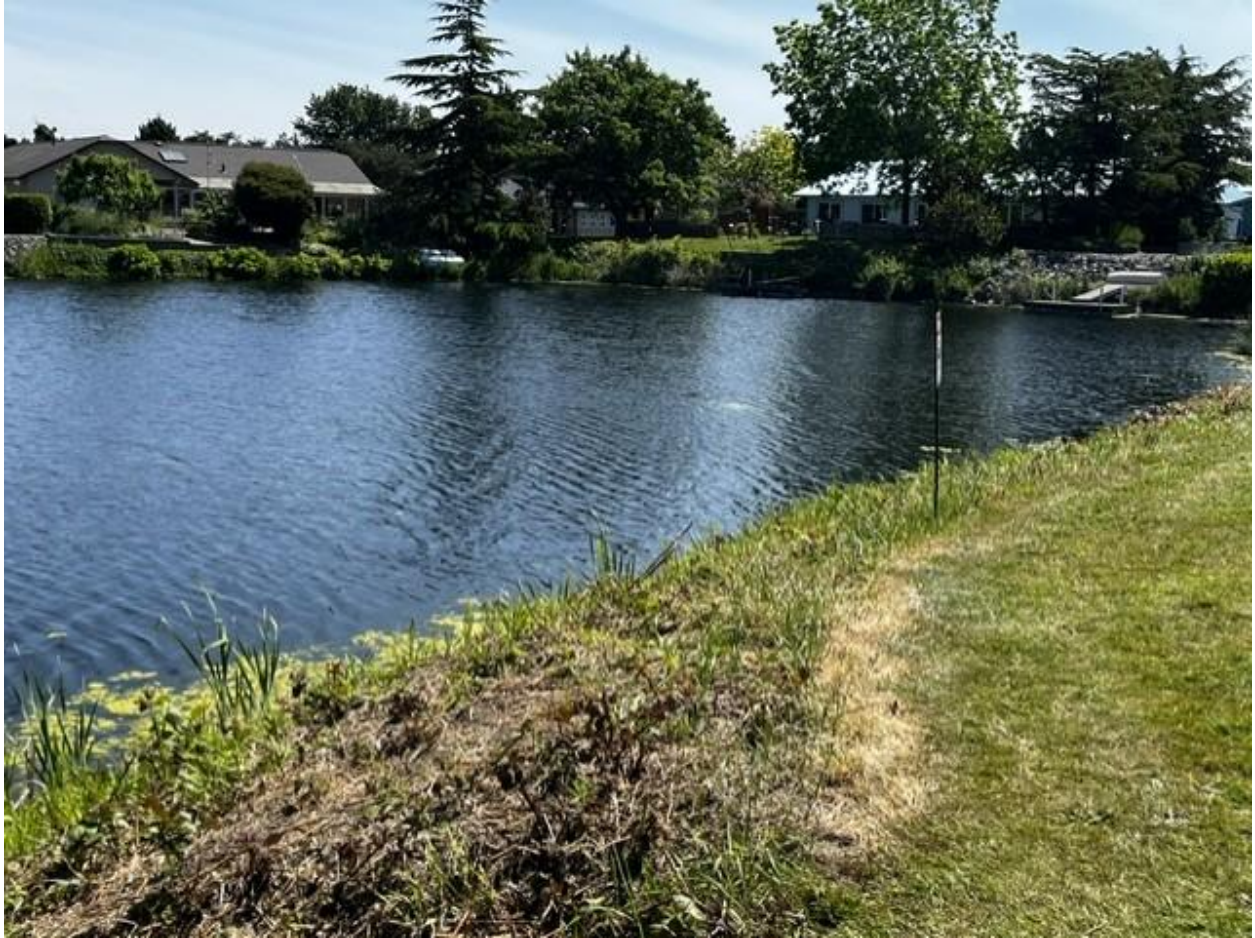
1. **SE Corner of Thunderbird Lake, 6/01/26.** Thunderbird Lake water generally clean and clear. Most of the lake surface is essentially devoid of filamentous algae as seen from this viewing location.

A notable increase in shoreline-edge filamentous algal mats since last month.

Shoreline plant growth (including blackberry bushes) along the southern edge (boat launch side) has been significantly reduced since last month. Maintenance staff has cleared areas more than usual at this location to provide more access for those persons fishing.

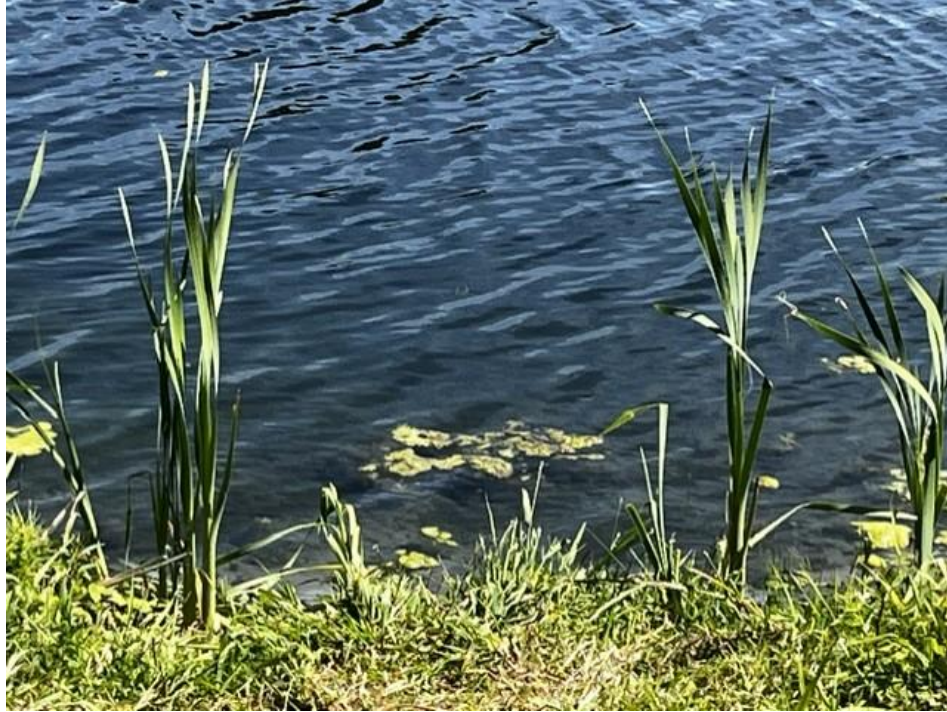
Closeup at this observation point on Thunderbird Lake still shows a relatively barren bottom with little signs of aquatic plant growth. Some isolated mats of filamentous algae floating near shore

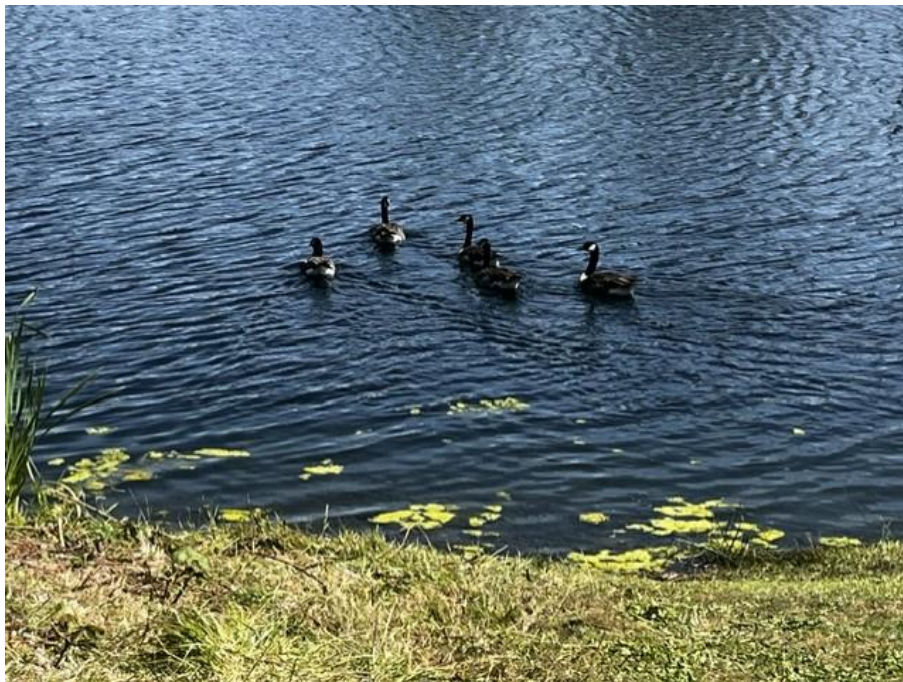
Visting Canada Goose population has now increased since last month. Aply doing their part to increase the nutrient loading for this water body.

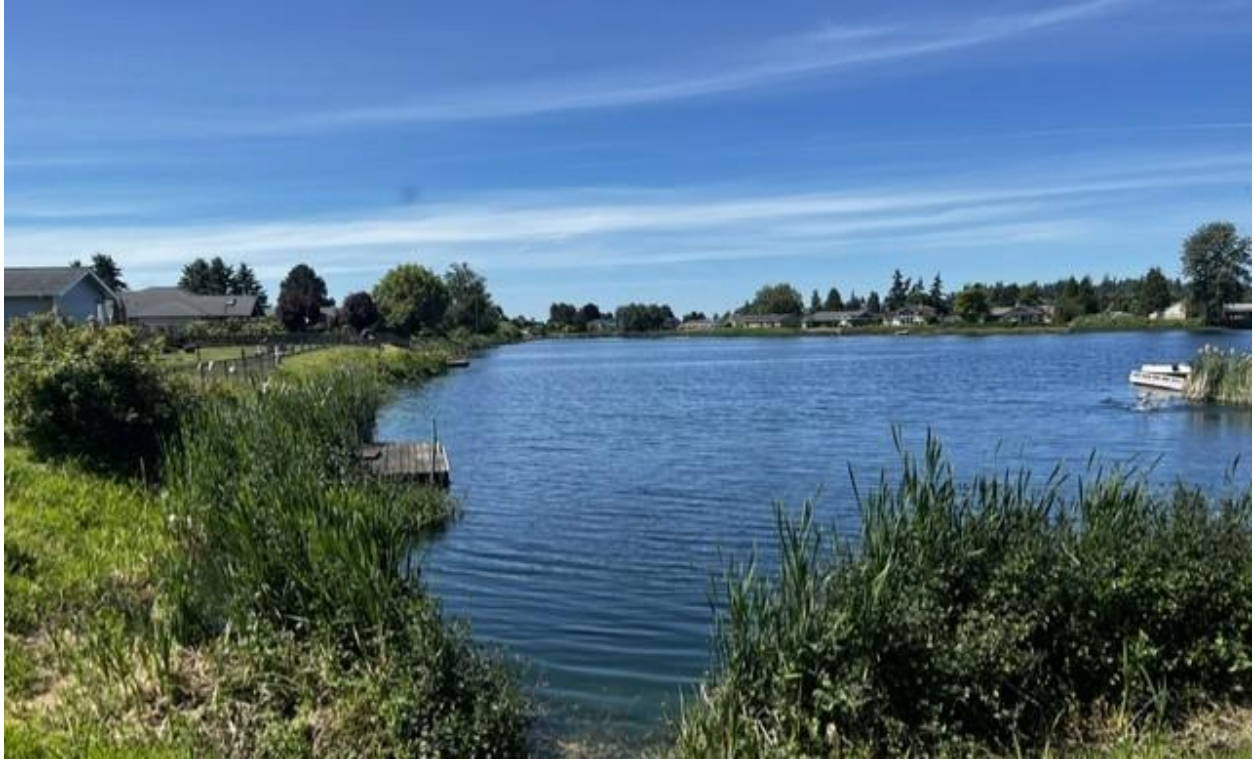
2. **NE Corner of Kwann Lake, 6/01/26.** No sign of any algae on the surface or along the edge here.

Maintenance has recently cleared shoreline-edge plants including canary grass, the usual/typical blackberry bushes, and some cat-tails in this area, down to the water's edge. This has created some additional open space for use by persons fishing here.

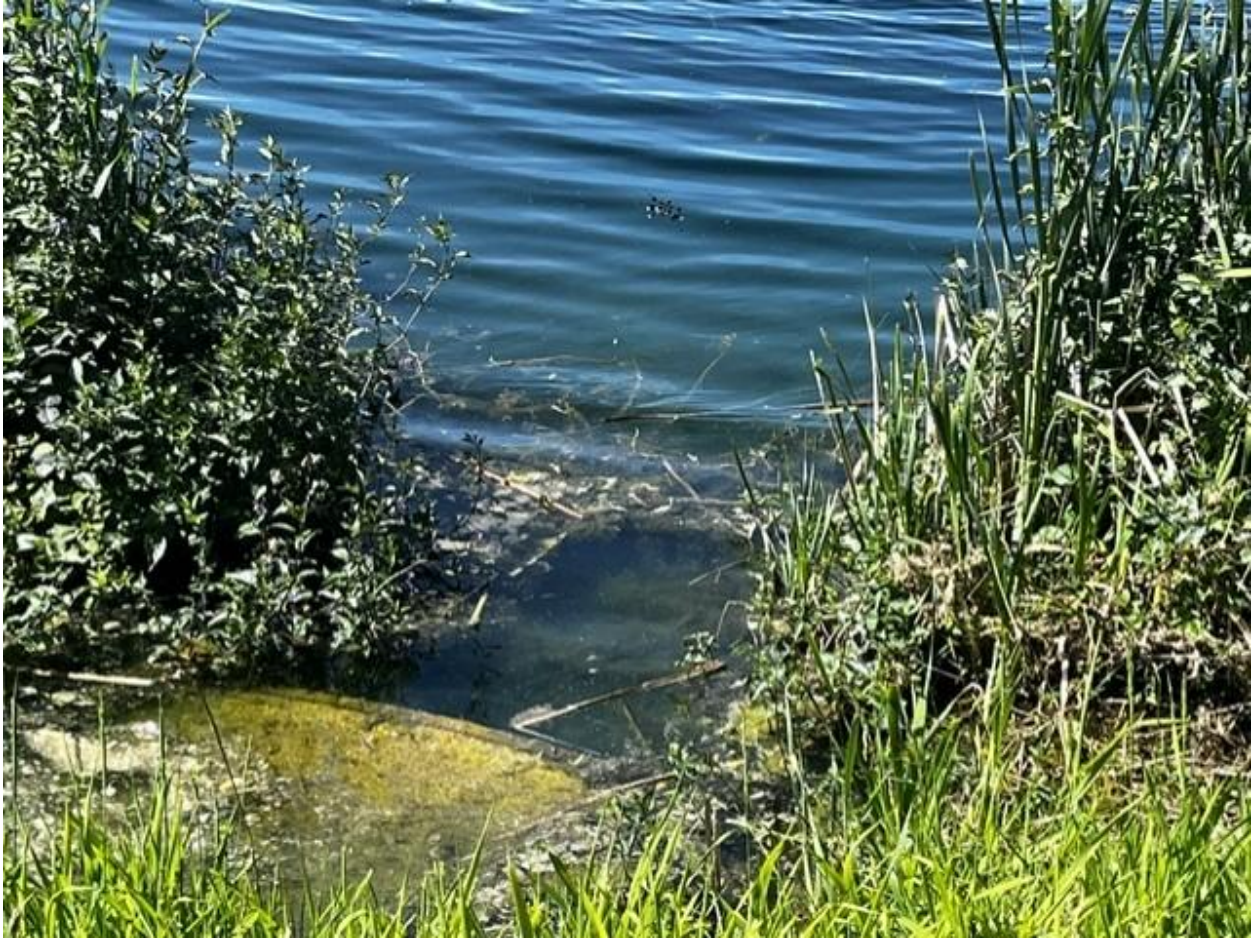
A closeup of this northeast corner of Kwann Lake shows the usual buildup of 'pond scum' with material floating on the surface: a mix of dead leaves, pollen, feathers and dust. The recent shoreline vegetation has left trimmed plant remnants that trap surface debris.

There are some early signs of bottom-growing aquatic plant material (possibly filamentous algae) attached to rocks etc. at this edge.

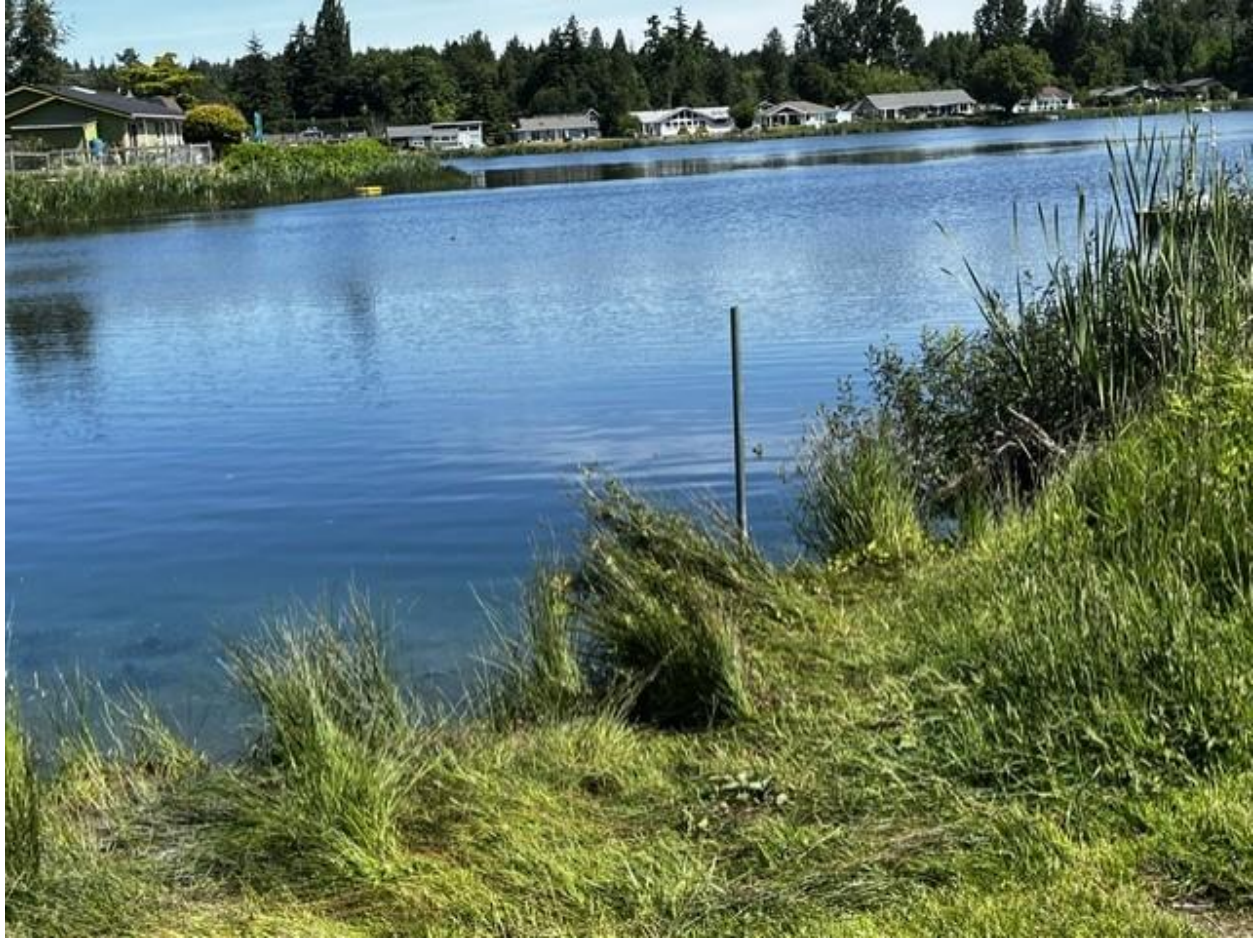
2a. **SE corner of Kwann Lake near boat launch.** 6/01/26. No signs of blue-green algae (or any other type of algae) present on the surface at this location. The lake as viewed here is generally clean and clear.

There are still very clear indications of last month's application of AquaShade UV blocker.. This gives the water a mild bluish coloration.

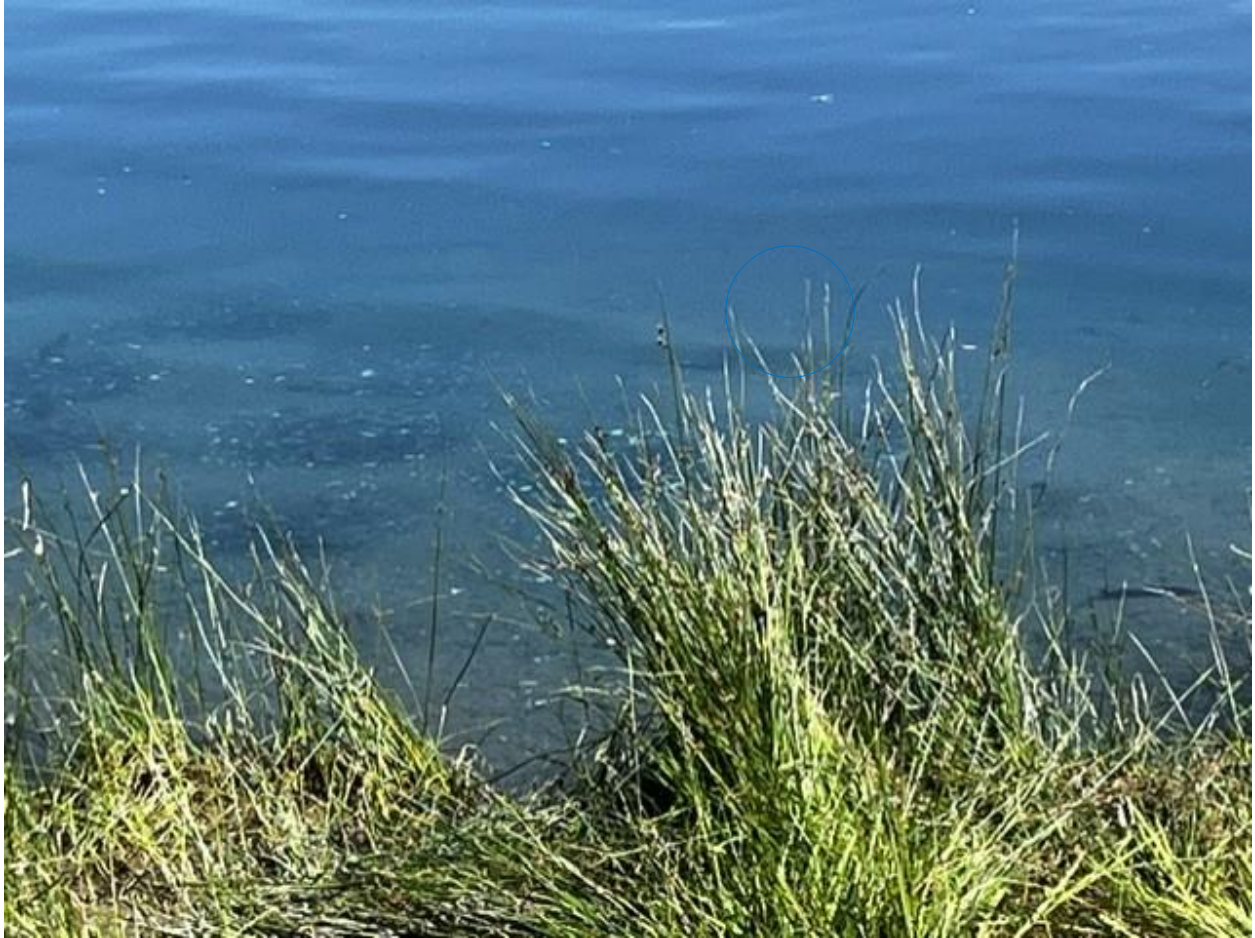
(2a cont'd.) Closeup of the SE corner of the Kwann Lake (boat launch site). Note the clean, clear bottom at this location. Some early signs now of aquatic plant or bottom-growing algae buildup, which was not present last month.

The clumps of sedge-type shoreline grasses that began to grow along the water's edge here about two years ago are well-established now.

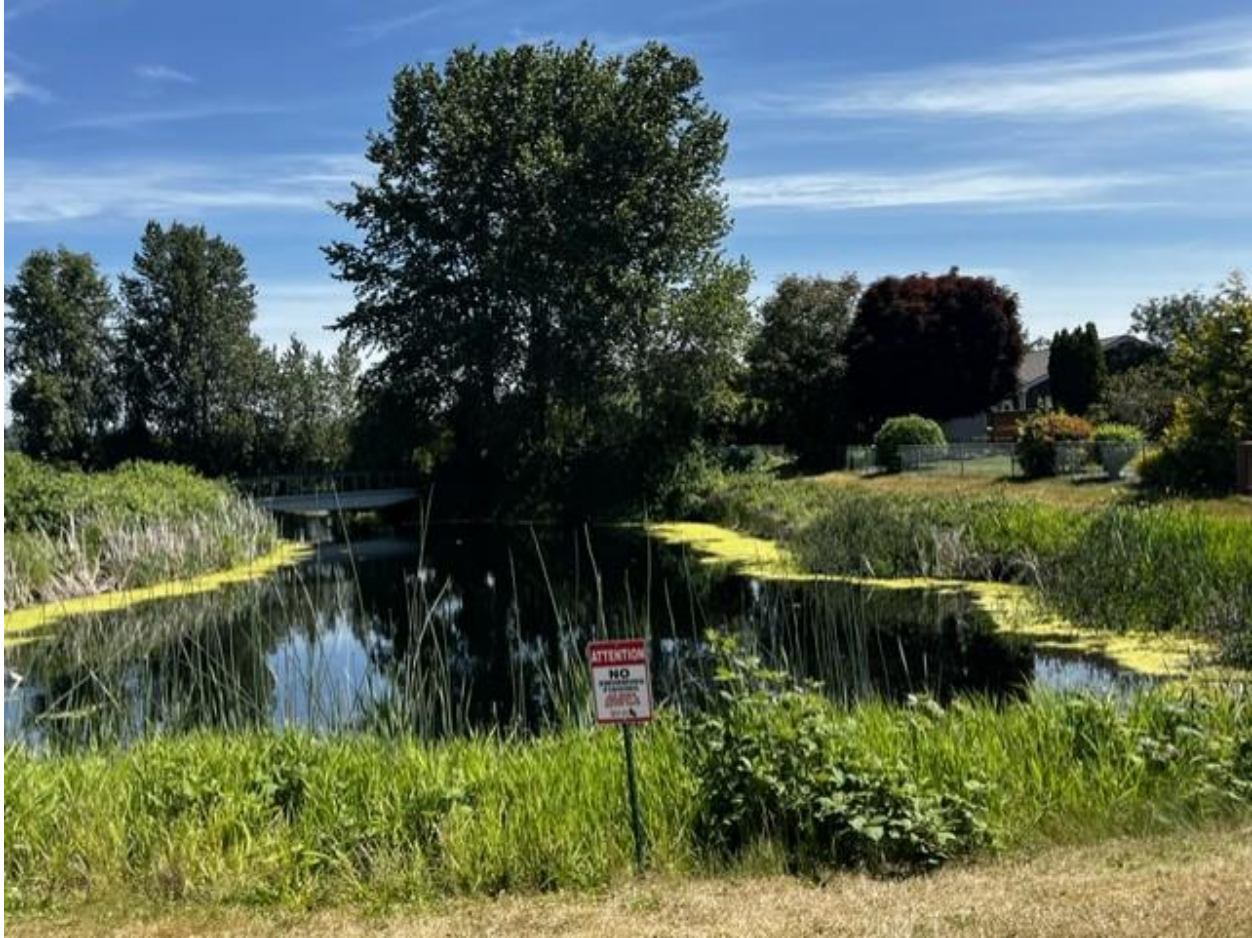
3. **South Golf Course Pond** – 6/01/26. Clear water with filamentous algae now appearing on the surface at both the eastern and western shoreline edges. This filamentous algae typically occurs at the south end of this pond each season, but usually not until later in the summer.

Shoreline plant growth (cattails, canary grass) has started to re-generate since its last trimming.

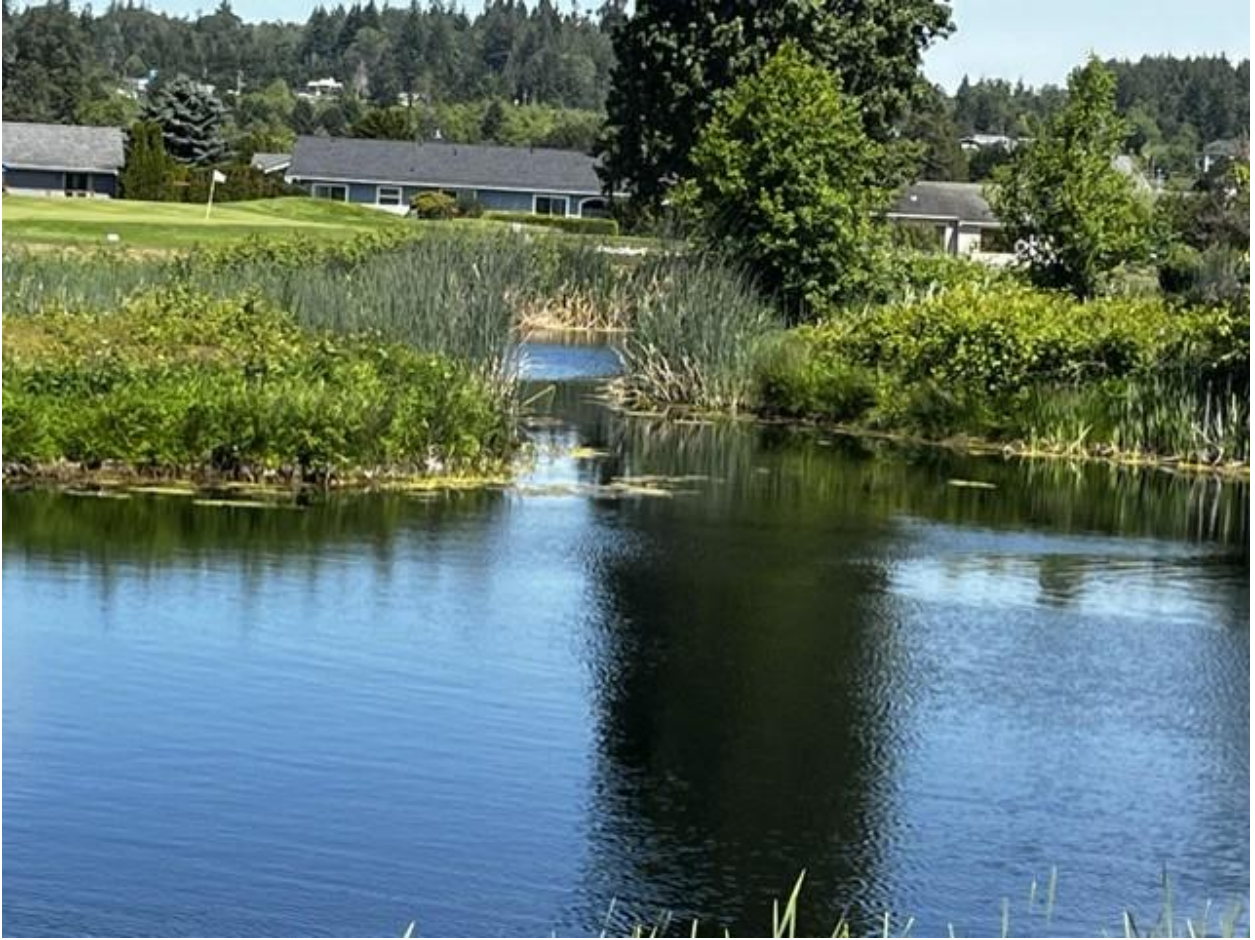
This photo was taken from the north side of the golf cart bridge on the South Golf Course Pond (#5). It shows how the pond-edge algal mats are appearing all around this water body. The algal mats seem to typically be held in place by the shoreline plant roots (cat-tails etc.).

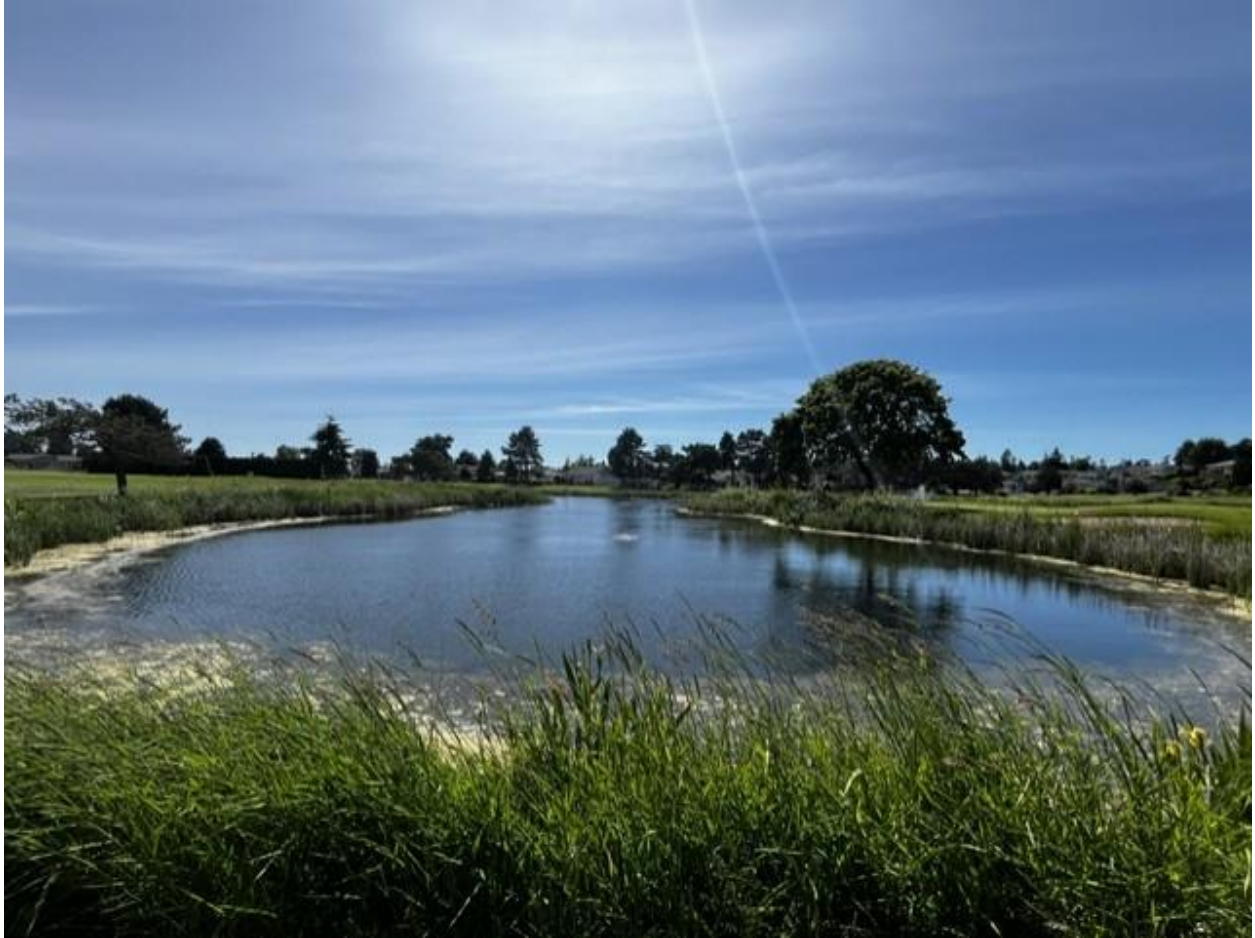
4. **North Golf Course Pond** - 6/01/26. Surface condition: Very little visible plant matter on the surface, more clear of surface plant material than it was last season, but some beginning to appear at edges.

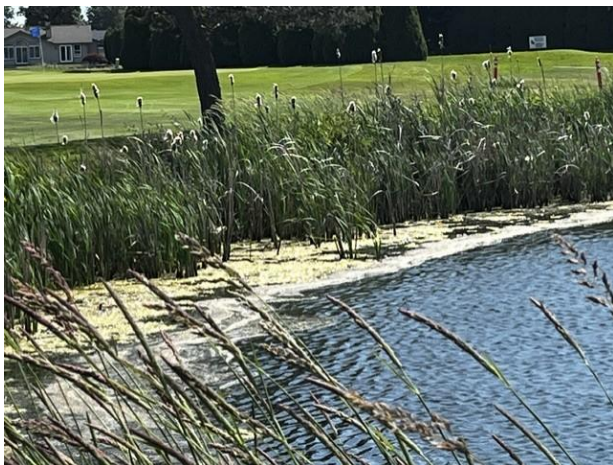
East edge, south side, some algal mats present

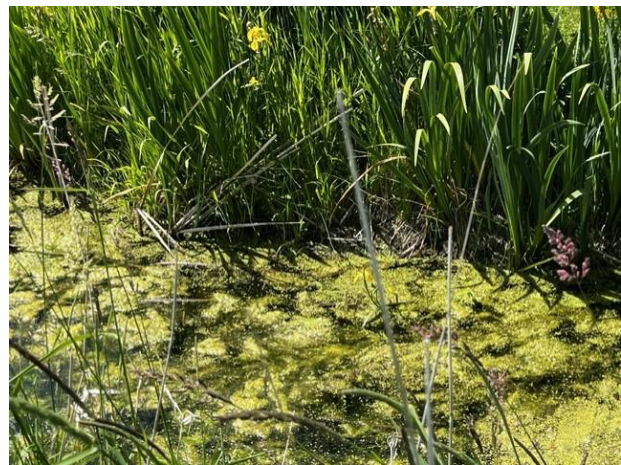
Far N.E. corner (near culvert): more plant debris and algae present here than was seen last month.

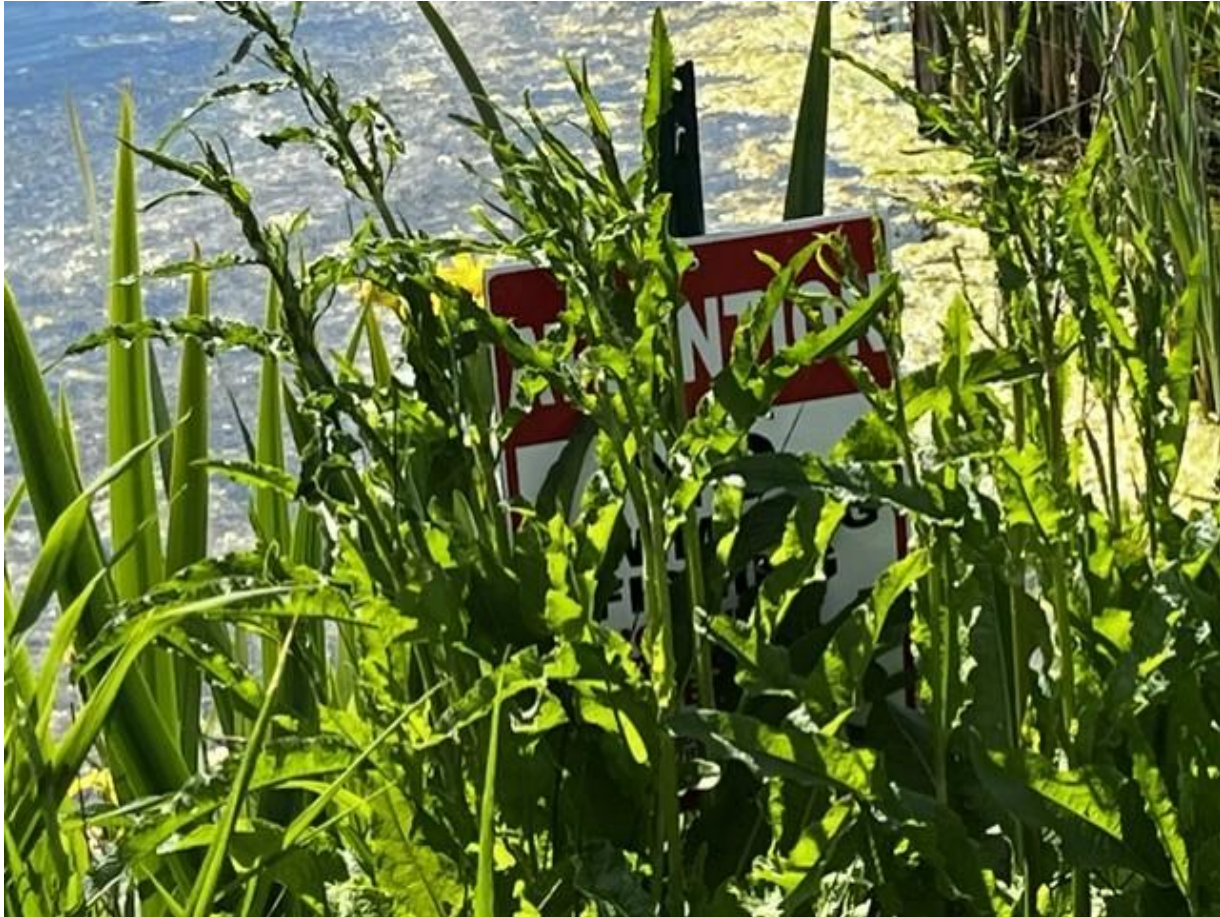
North Golf Course Pond, cont'd. : Shoreline plant growth height has increased since last month.

With much of the shoreline cat-tail population having been cleared during the past season, this pond-edge growth is now coming in as a blended, random mix with several varieties of fast-growing “weed” type plants.

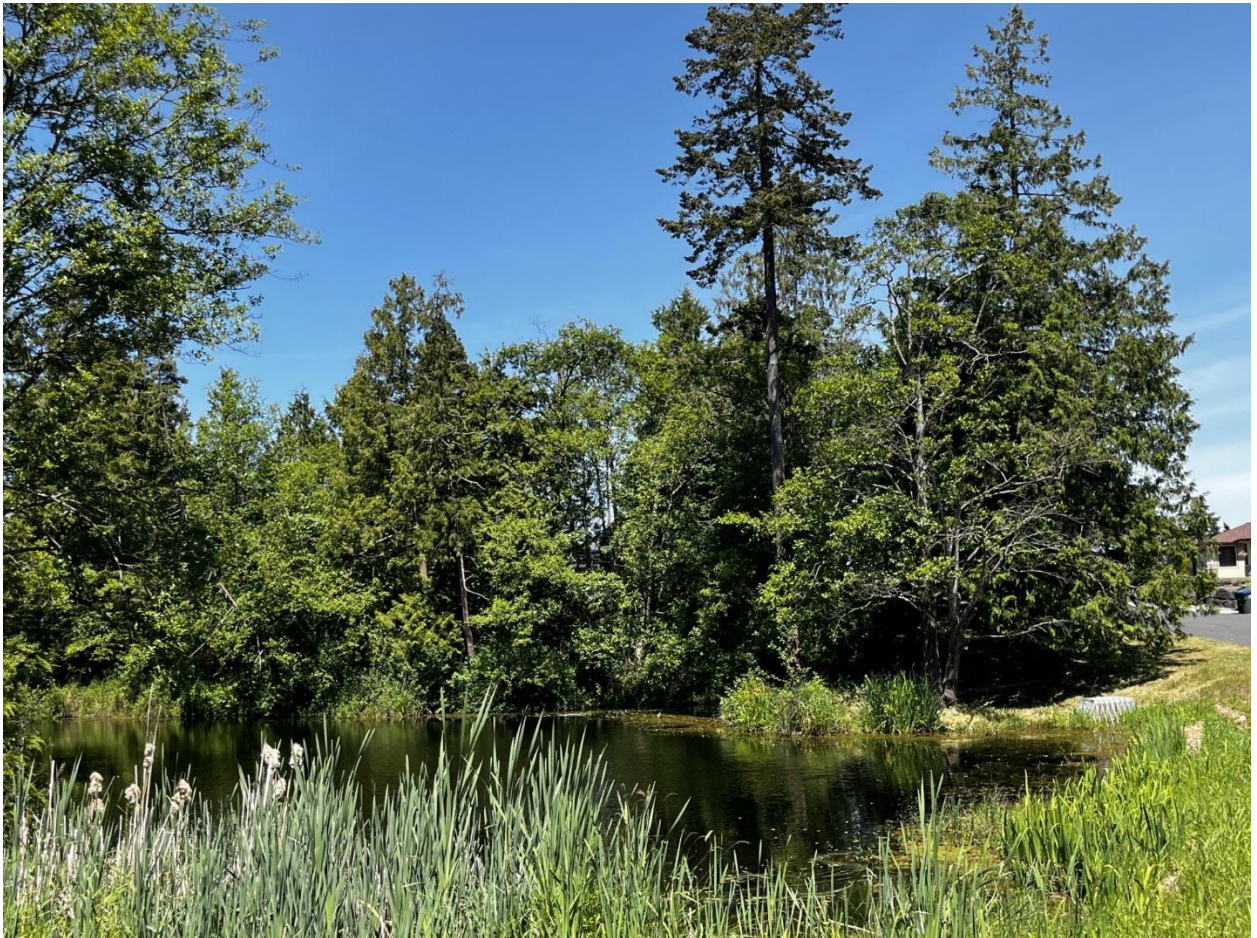
6/1/26- Beaver Pond as seen from its lower (south) end, viewed from Chinook Way.

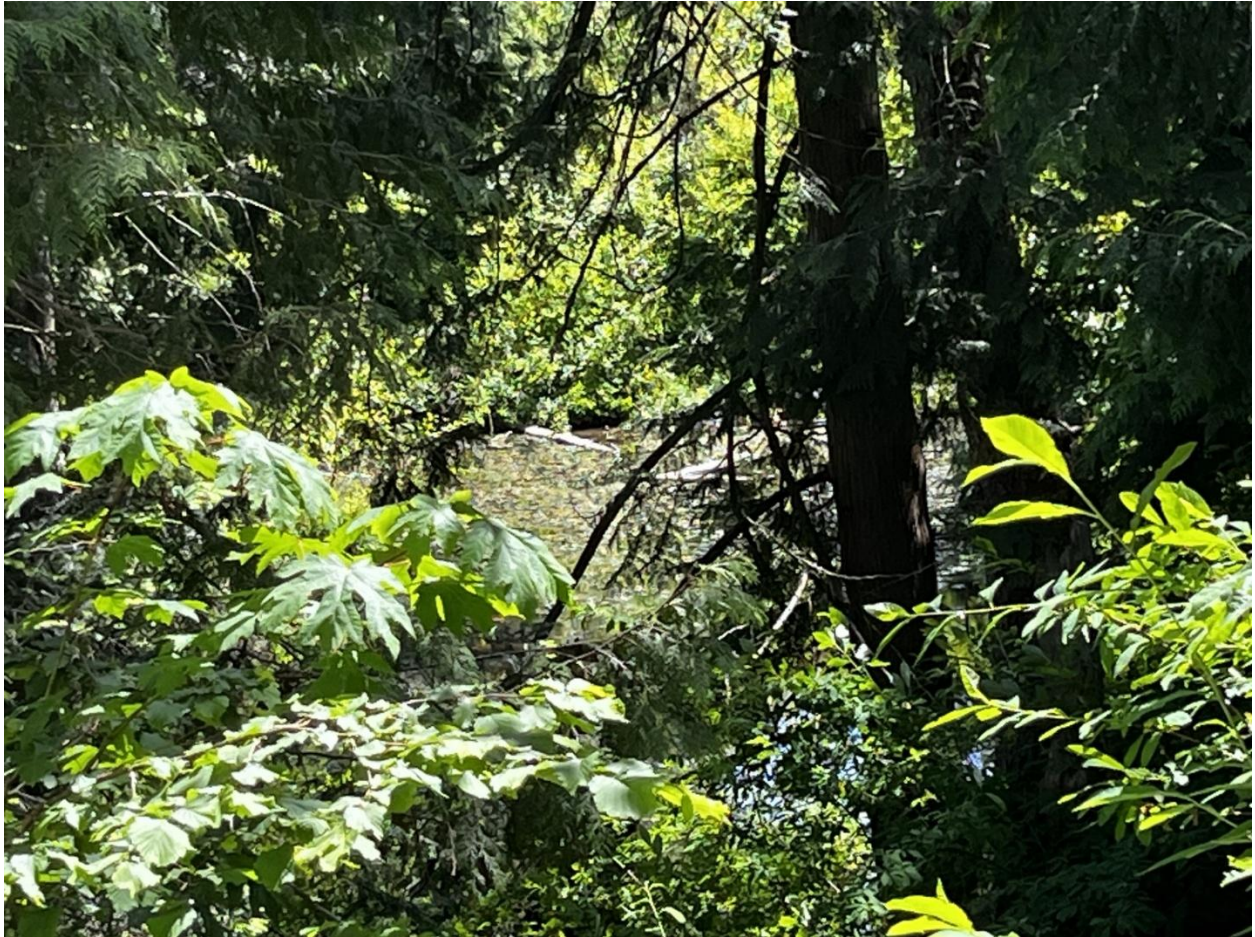
The interior reaches of Beaver Creek and the “Beaver Pond” do have a much wilder, more “woody” feel.

The stretch shown above has bank-to-bank aquatic plant growth on the surface, and there are numerous floating logs and dead branches in evidence. This condition precludes much human on-water activity (such as small personal watercraft).
