To: BBV Lakes, Ponds & Drainage Committee

JULY MTG. REPORT [ actual: 6/26/26 ]

**RE: BBV LAKES & POND ALGAE, CURRENT CONDITIONS**

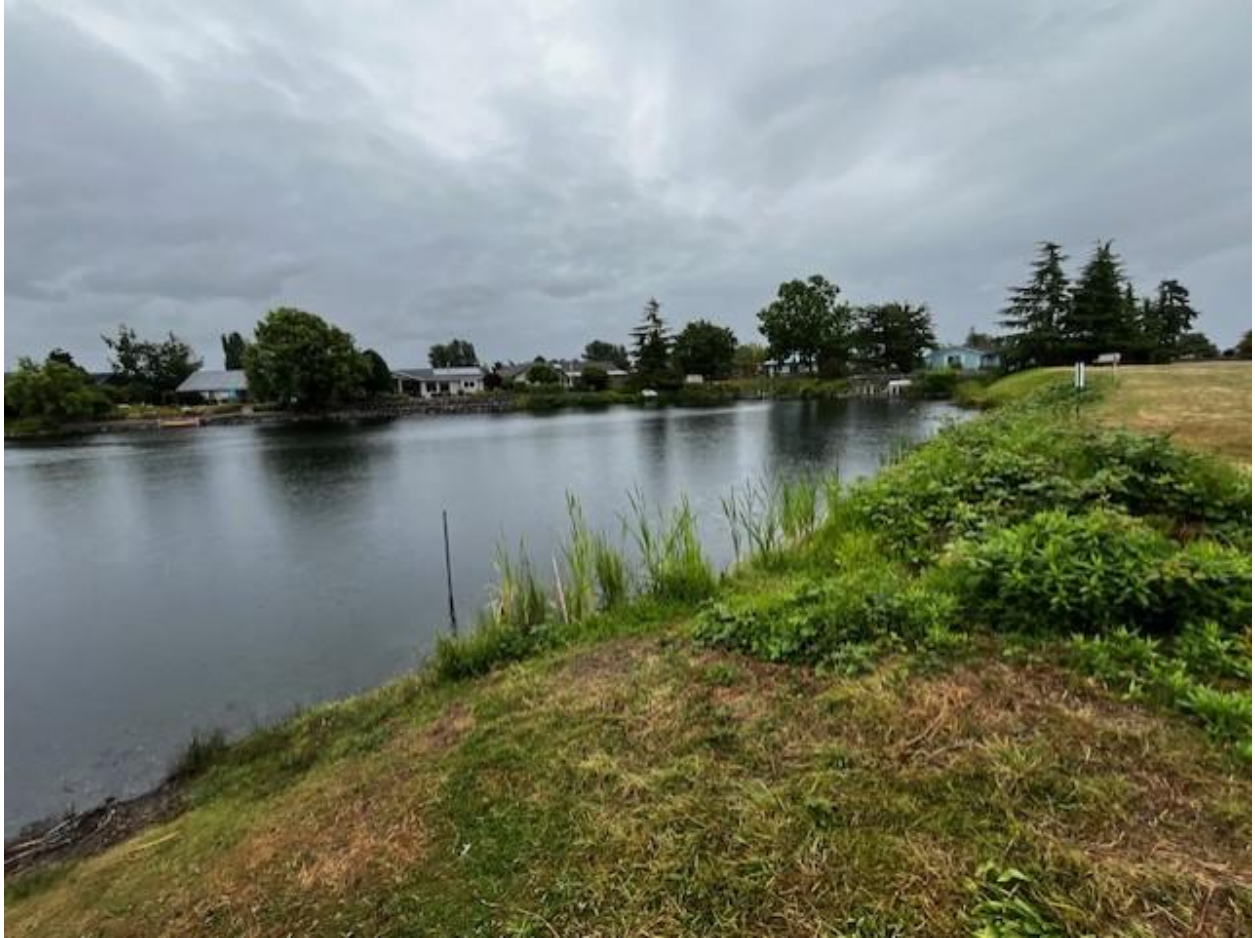
1. **SE Corner of Thunderbird Lake, 6/26/26.** Thunderbird Lake water generally clean and clear. The lake surface is essentially devoid of filamentous algae as seen from this viewing location. Only some very modest amounts near the homeowner's dock that can be seen in the distance at right in this photo.

A very notable decrease in shoreline-edge filamentous algal mats since last month. It could be that the frequent winds (gusts up to 15 mph) over the past 1-2 weeks have blown surface mats from this end of the lake, to the north. Unconfirmed.

Shoreline plant growth (including blackberry bushes) along the southern edge (boat launch side) is slowly recovering. Maintenance staff previously cleared areas at this location more than usual to provide more access for those persons fishing.

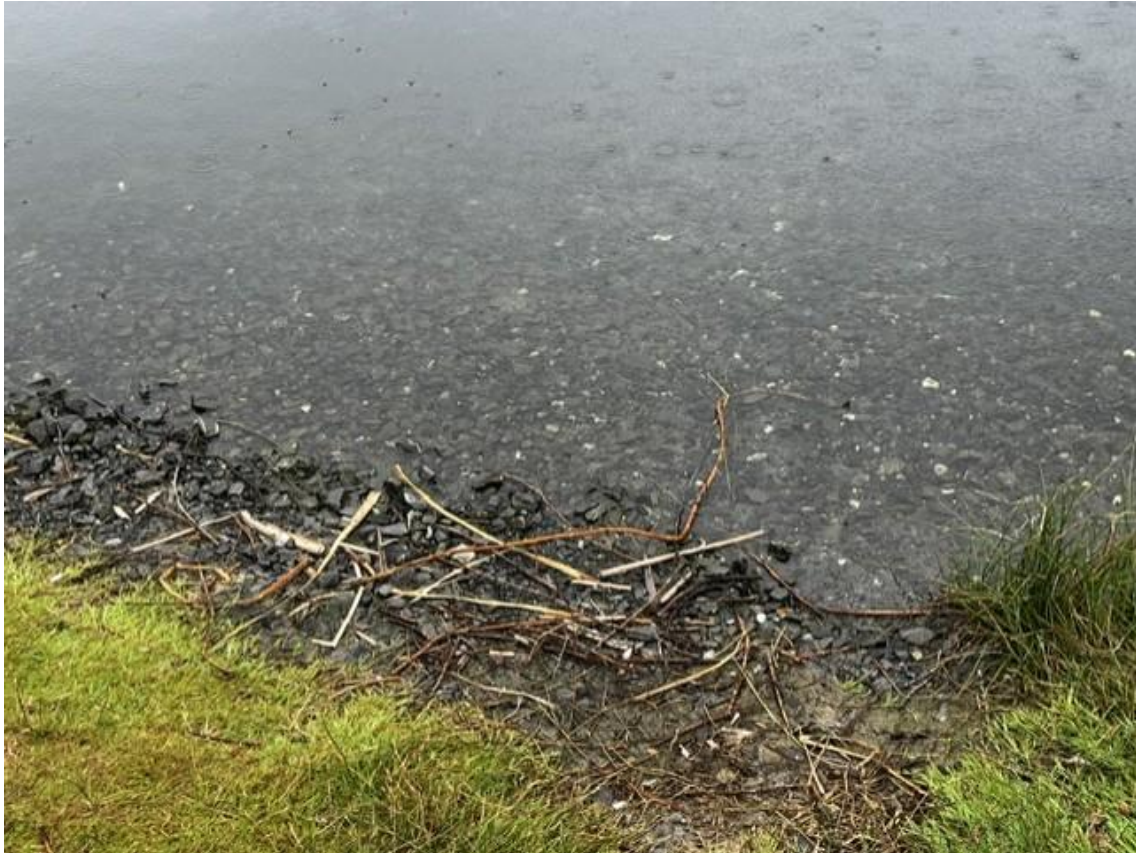
Closeup at this observation point on Thunderbird Lake shows a relatively barren bottom with very little signs of aquatic plant growth. Area seems more traffic-impacted since last month, likely due to the current fishing program which brings more persons to this area.

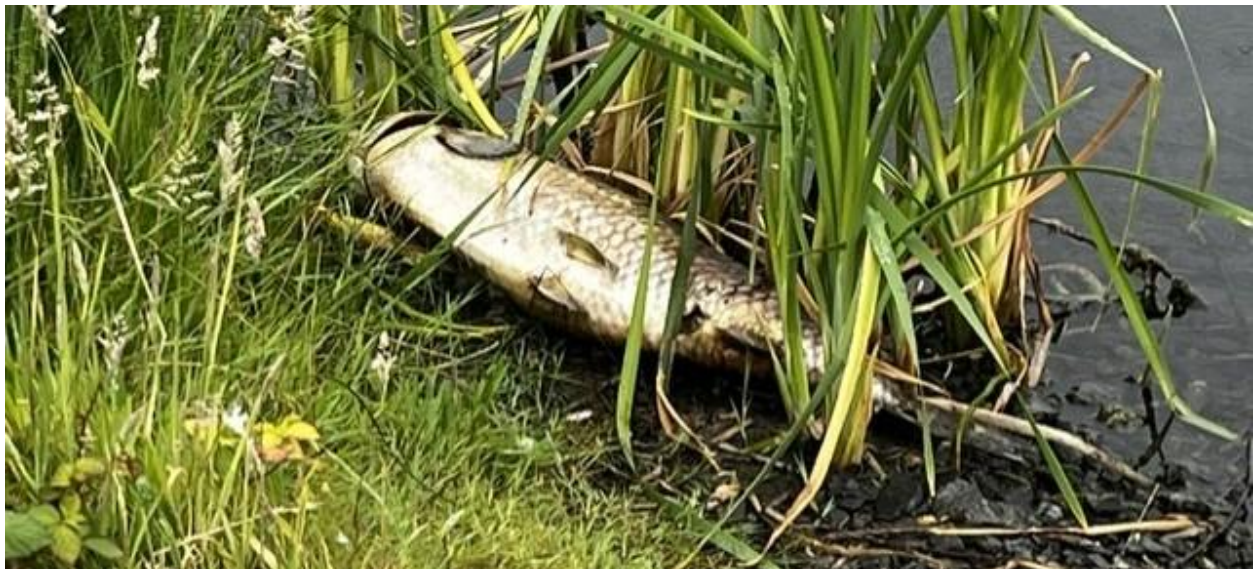
Dead mature Asian grass carp observed at this site (just to the left of this boat launch area). Cause of death unknown.

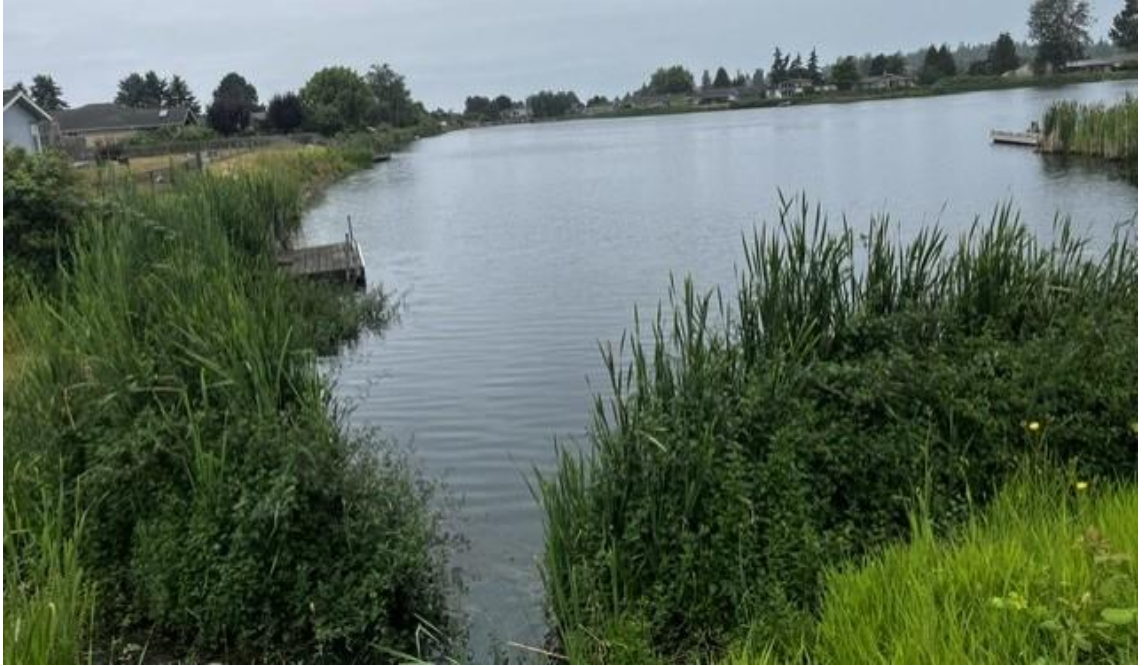
2. **NE Corner of Kwann Lake, 6/26/26.** No sign of any algae on the surface or along the edge here.

Maintenance recently cleared even more of the shoreline-edge plants including canary grass, the usual/typical blackberry bushes, and some cat-tails in this area, down to the water's edge. This has created more open space for use by persons fishing here.

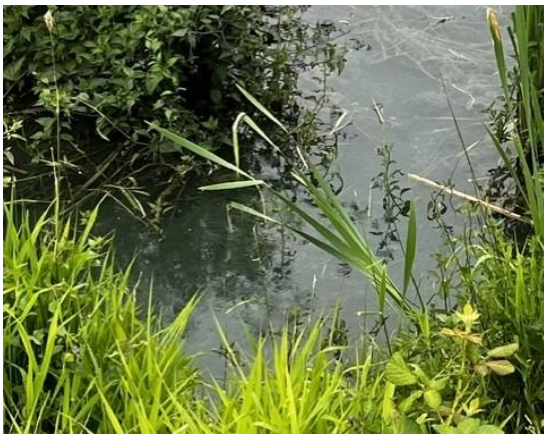
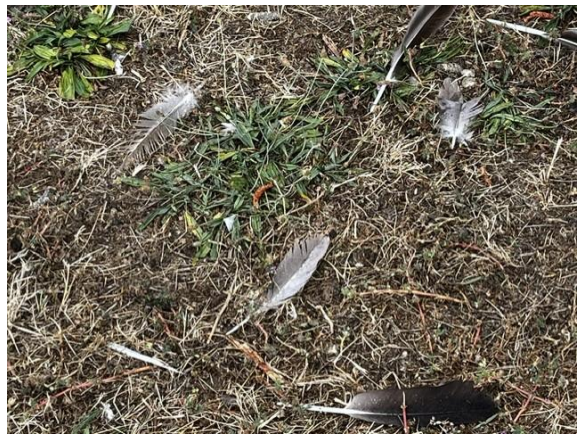
Closeup [below] of this northeast corner of Kwann Lake shows the usual buildup of 'pond scum' on the surface: a mix of dead leaves, pollen, feathers and dust. More submerged, built-up trimmed vegetation in this corner than usual.

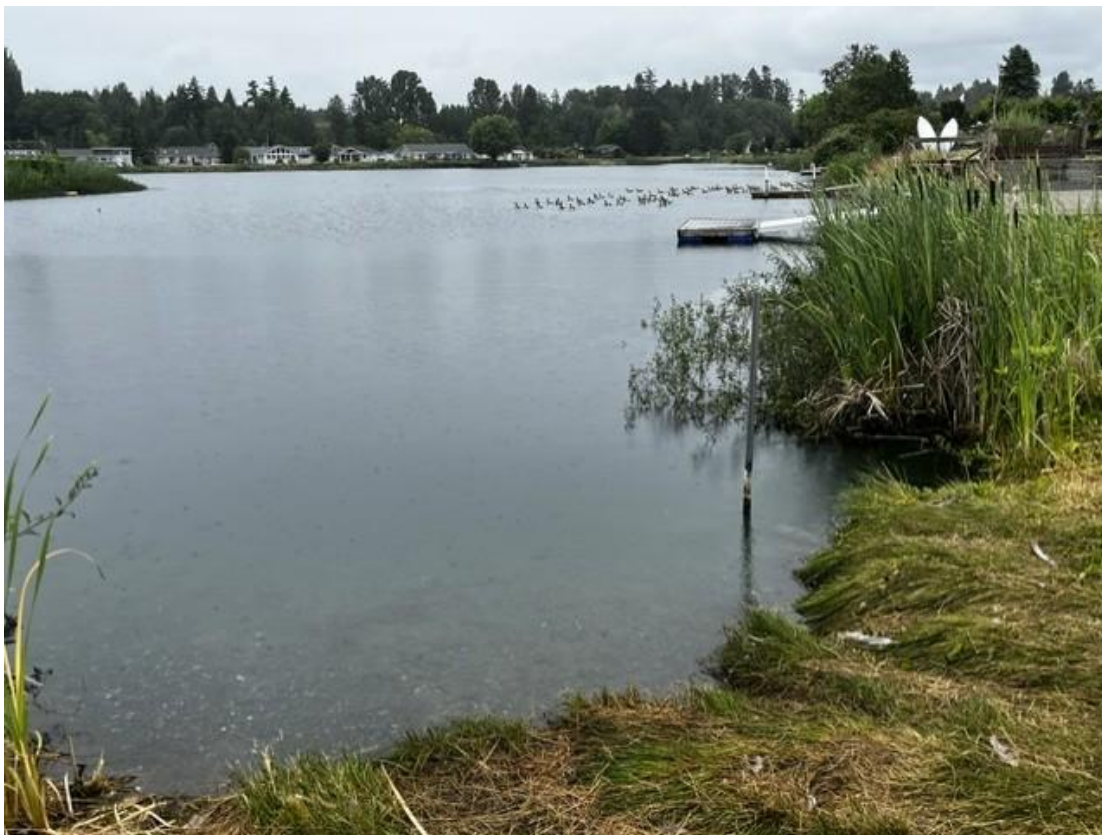
Significant amt. of goose feces & feathers here.

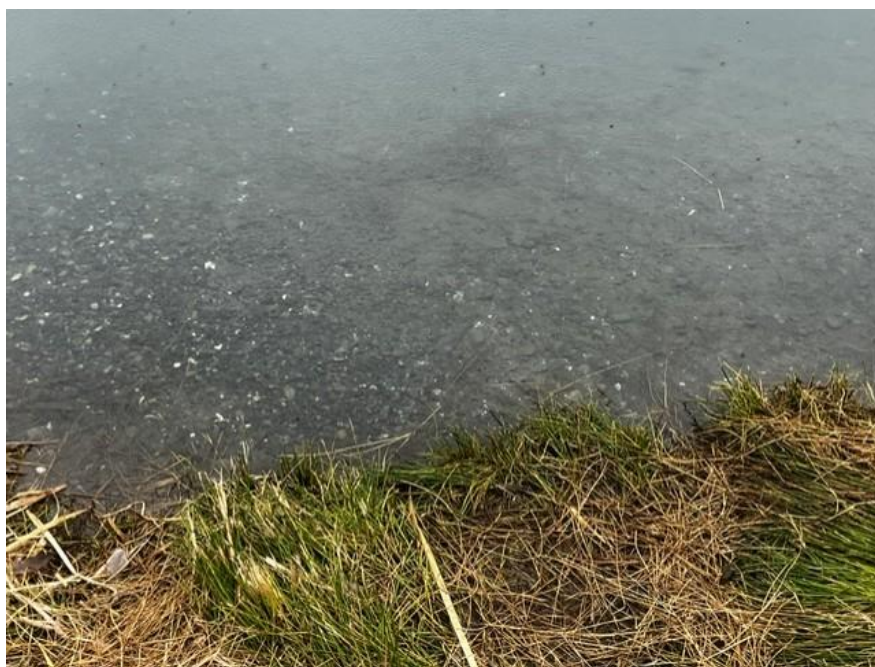
2a. **SE corner of Kwann Lake near boat launch.** 6/26/26. No signs of blue-green algae (or any other type of algae) present on the surface at this location. The lake as viewed here is generally clean and clear.

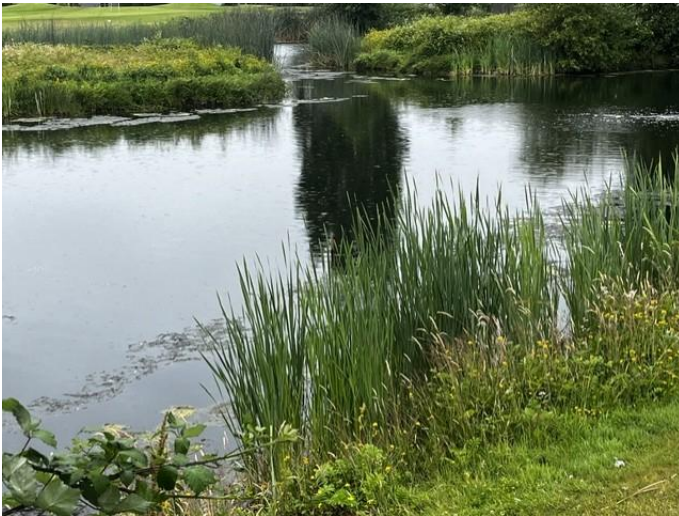
3. **South Golf Course Pond (#5)** – 6/26/26. Filamentous algae still appearing on the surface at both the eastern and western shoreline edges. Modest increase since last month.

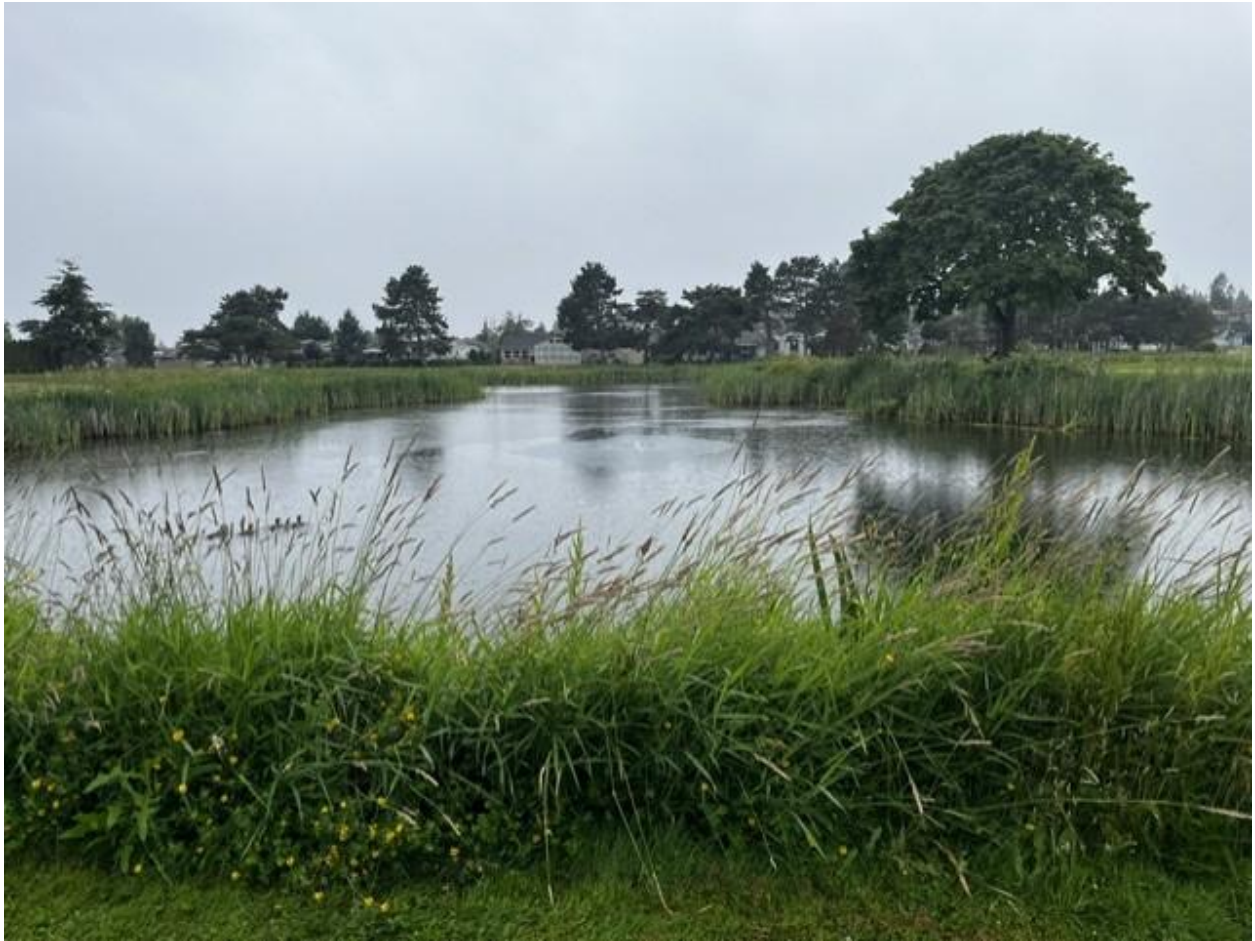
Pond #5 as viewed from east edge, north of the bridge. Aerator is functioning; algal mats on surface similar to last month.

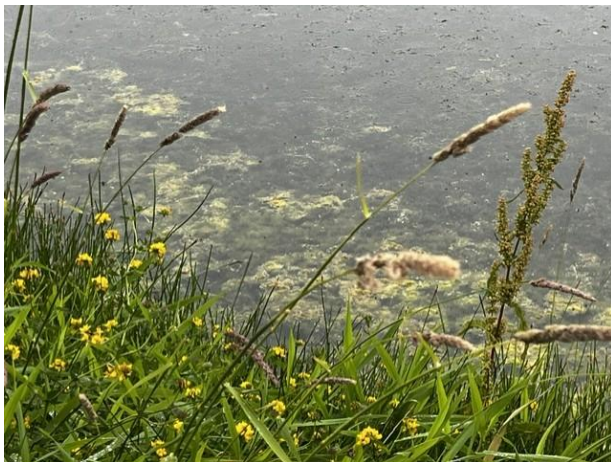
4. **North Golf Course Pond** - 6/26/26. Surface condition: Very little visible plant matter on the surface, less than last month. some at the eastern edge. Shoreline plants have grown since last month.

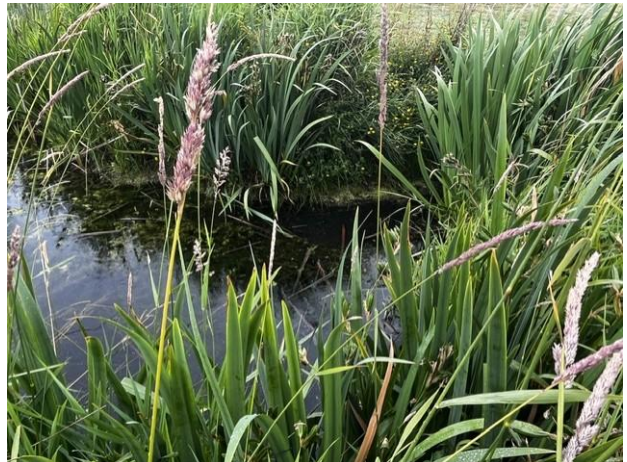
East edge, some fresh algal mats present

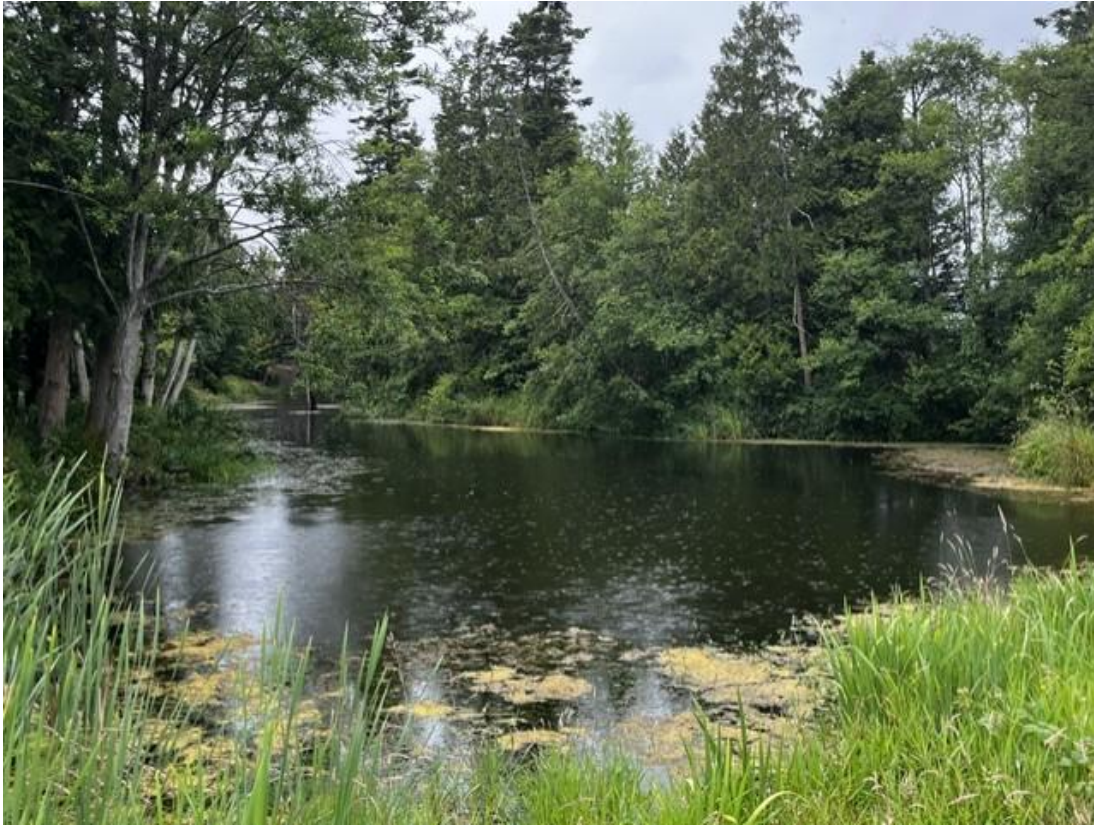
Far N.E. corner (near culvert): less plant debris present than last month. Duckweed nearly gone.

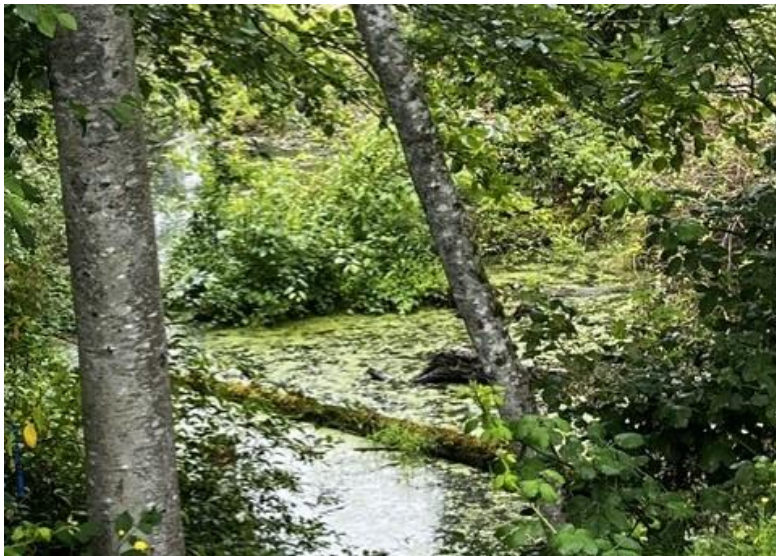
6/26/26- Beaver Pond, lower (south) end, viewed from Chinook Way. Conditions similar to last month.
