AUGUST MTG. REPORT

**RE: BBV LAKES & POND ALGAE, CURRENT CONDITIONS**

This is the fourth report for the 2026 season, with photos and notes on five different water bodies being taken. These include **Thunderbird Lake** SE corner, **Kwann Lake** [NE corner + SE corner] the **South Golf Course Pond #5**, and the **North Golf Course Pond #1**. When available we also include photos and notes from the other (mid-course) golf course ponds # 2,3 and 4. The **Beaver Pond** is also now being included.

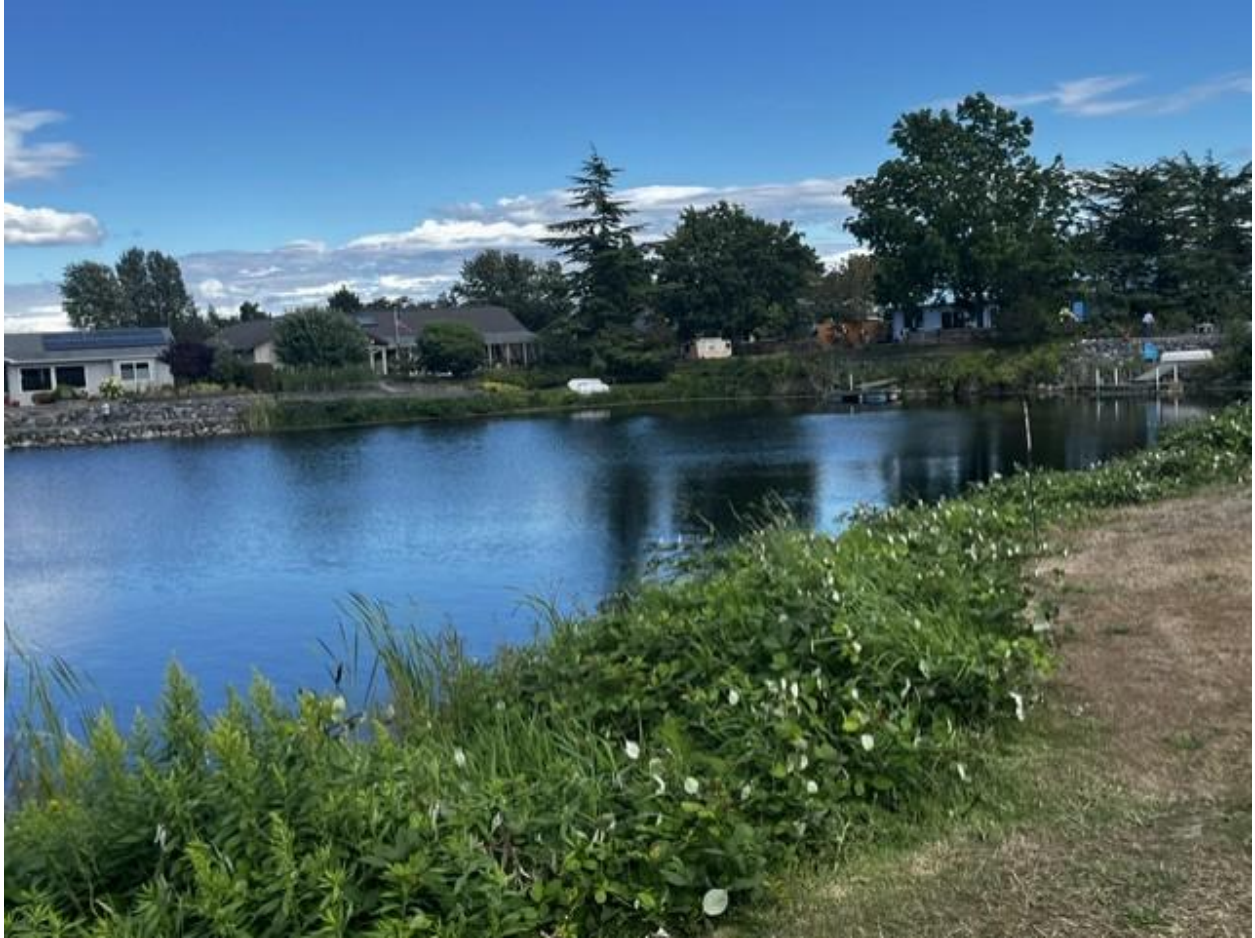
1. **SE Corner of Thunderbird Lake, 8/1/26.** Thunderbird Lake water generally clean and clear. The lake surface is essentially devoid of filamentous algae as seen from this viewing location. Some very modest amounts near the edge that can be seen in the distance of this photo.

Shoreline plant growth (including blackberry bushes) along the southern edge (boat launch side) has been trimmed.

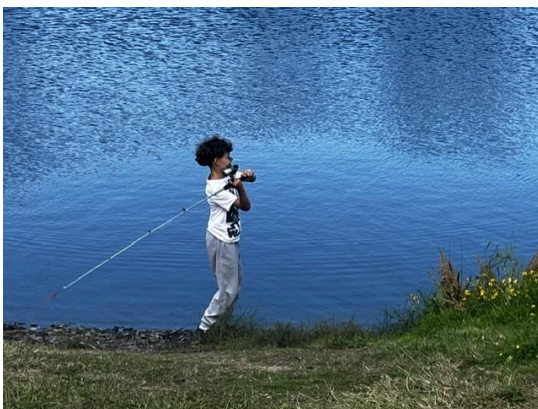
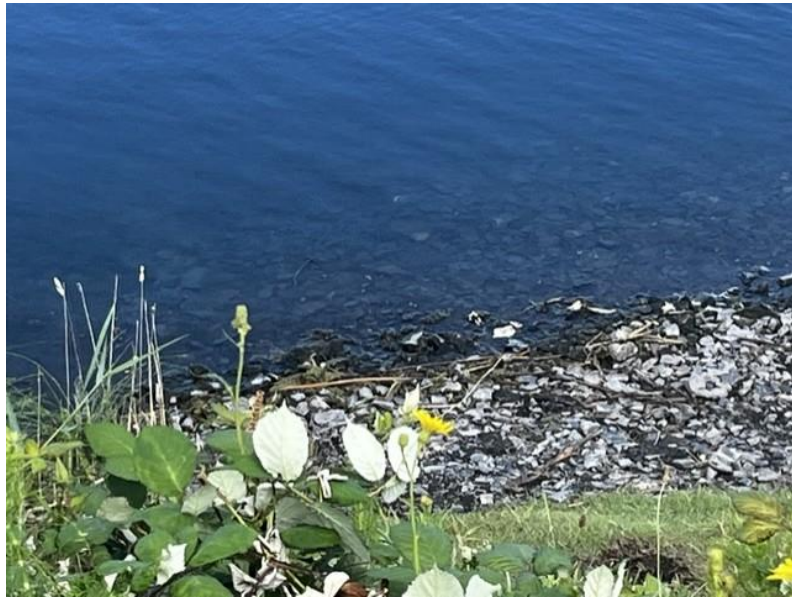
**Bonus photo:**

Closeup at this observation point on Thunderbird Lake shows a relatively barren bottom with little signs of aquatic plant growth, as last month. Reduced amount of goose feces compared to last month.

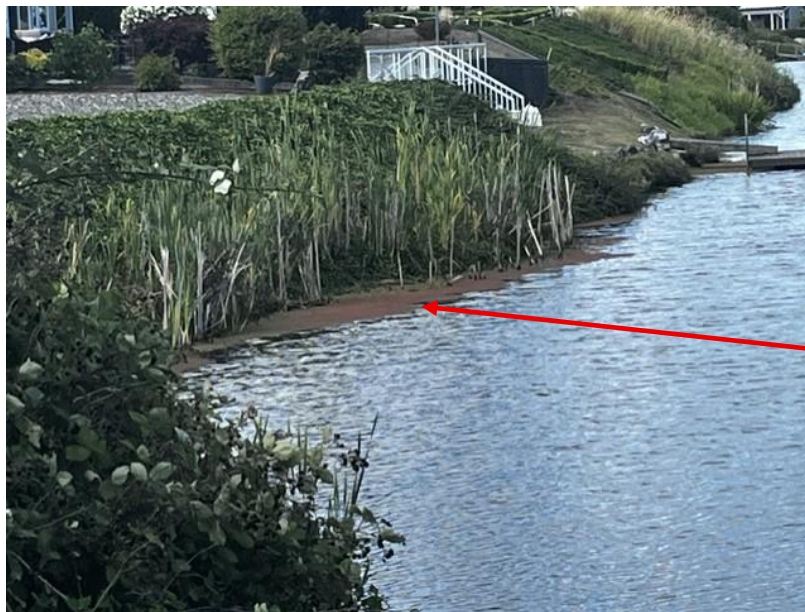
West edge as viewed from South end, at boat launch: something that bears watching is the plant growth showing up at the base of the cattails, visible on the surface. This does not appear to be filamentous algae (unless it is in a die-off phase) and does not appear to be milfoil. It is similar to a newly appearing surface plant at the Beaver Pond (see closeup photo in that section of the report). With what seem to be tiny, clustered leaflets and a grey green/rusty-red appearance, this may be Azolla. This plant in this location of Thunderbird Lake needs positive identification.

1. Consider determining a way to reduce the large Azolla mat in Golf Pond #4: could cause a fish kill due to oxygen level reductions. And monitor the new growth in Golf Pond #1.
2. Closely watch what is possibly Azolla growing on the west edge at the south end of Thunderbird.
3. Monitor the south end of the Beaver Pond to see if Azolla mats increase next month.

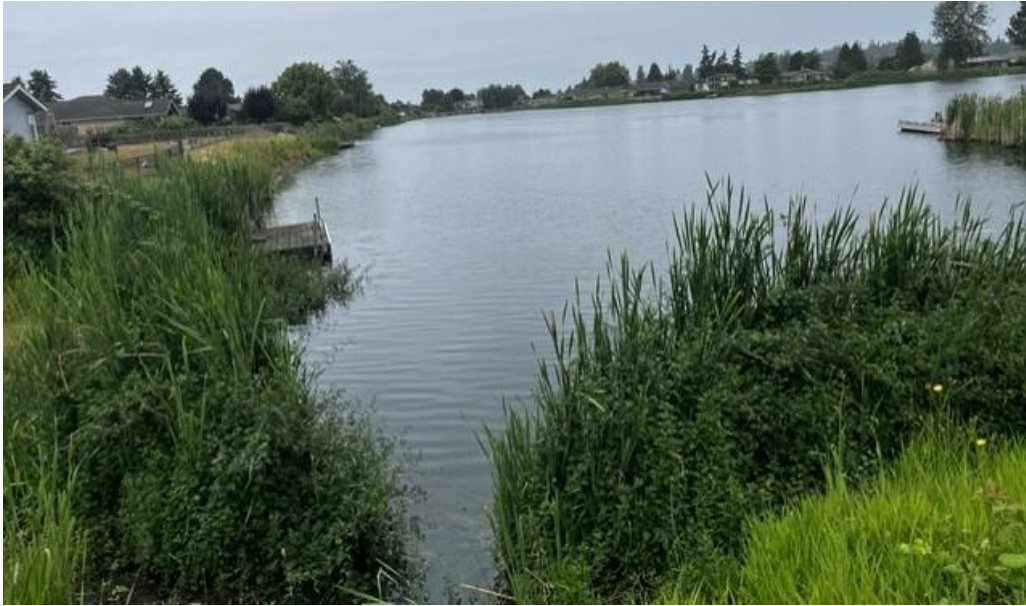
2. **NE Corner of Kwann Lake, 8/1/26.** No sign of any algae on the surface or along the edge here.

Maintenance recently cleared patches of the shoreline-edge plants including canary grass, the usual/typical blackberry bushes, and some cat-tails in this area, down to the water's edge. This growth is recovering, and the openings appear to have encouraged proliferation of the nightshade that is present at this corner of Kwann Lake.

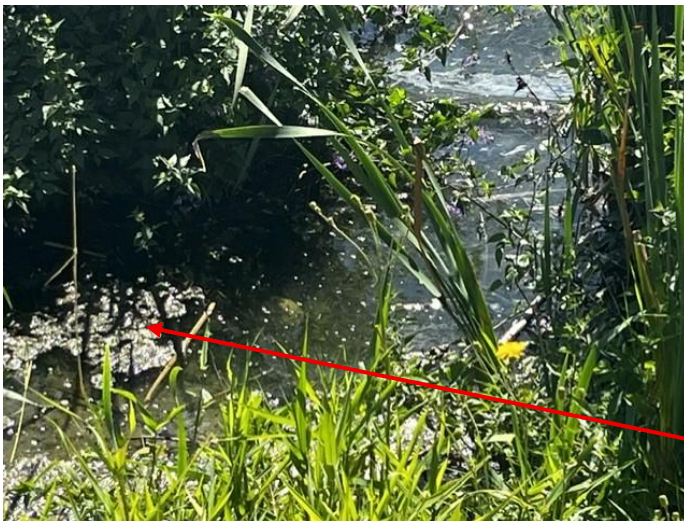
Maybe  
Filamentous  
Algae?

Closeup [below] of this northeast corner of Kwann Lake shows a less-than-usual amount of 'pond scum' on the surface: a mix of dead leaves, pollen, feathers and dust. More submerged, built-up trimmed vegetation in this corner than usual. Some small globs of what may be filamentous algae, unusual for Kwann Lake.

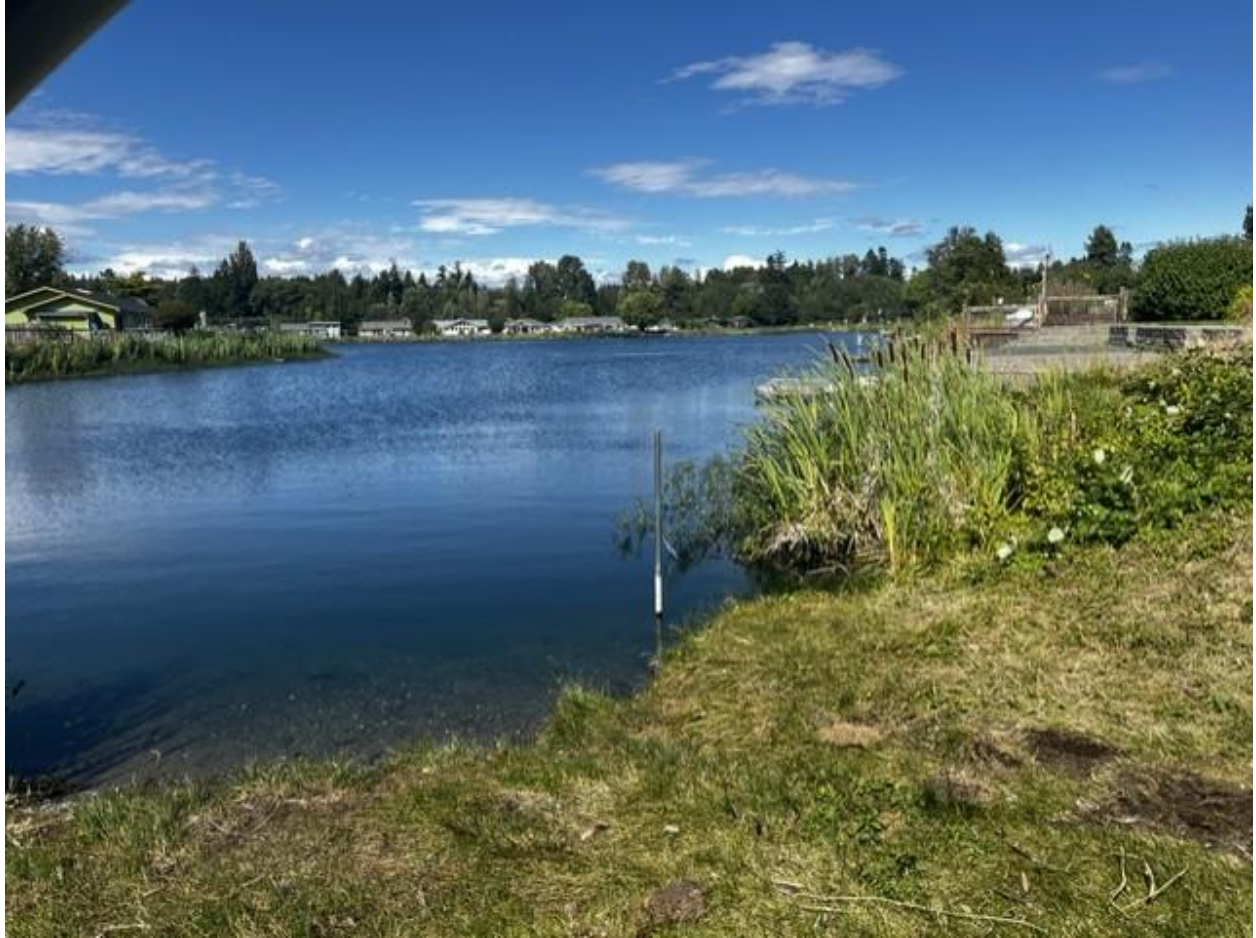
2a. **SE corner of Kwann Lake near boat launch.** 8/1/26. No signs of blue-green algae (or any other type of algae) are present on the surface at this location. Lake as viewed here generally clean and clear.

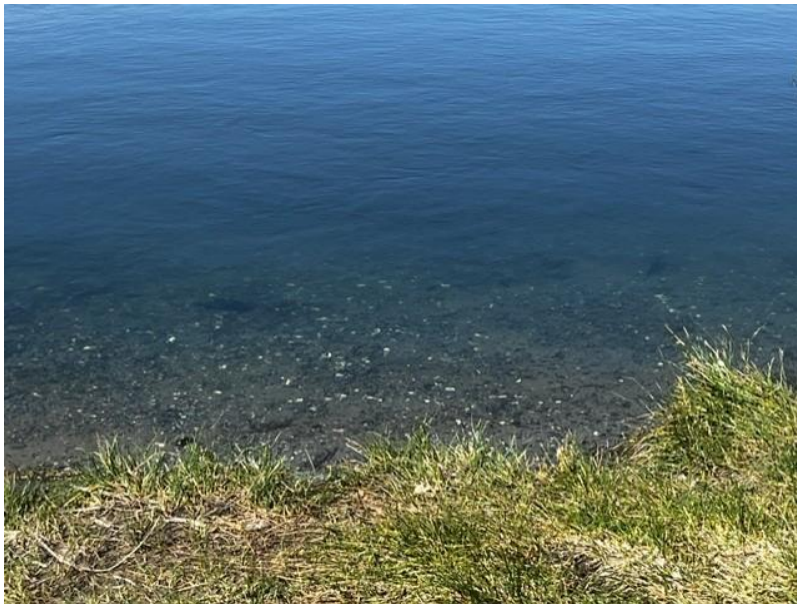
Closeup at this SE Corner (boat launch). Ultra-shade UV-blocker is still clearly present (note bluish tint).

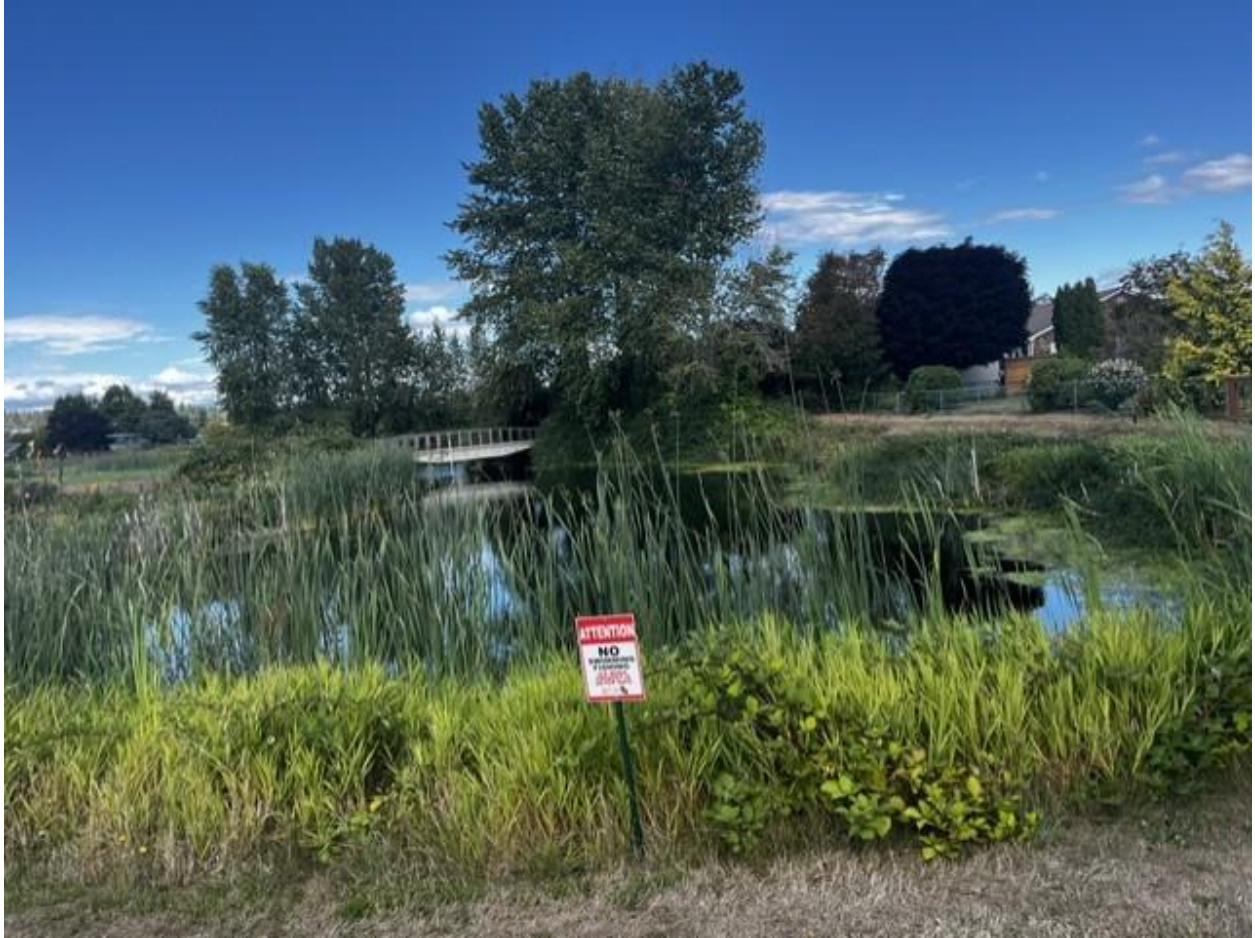
3. **South Golf Course Pond (#5)** –8/1/26. Filamentous algae still appearing on the surface at both the eastern and western shoreline edges. About the same as last month. Plants at edge are higher.

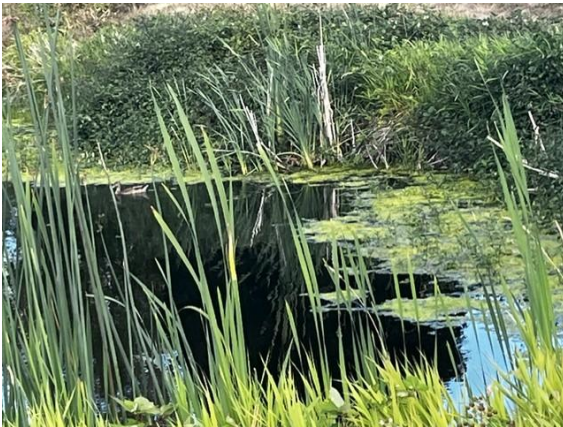
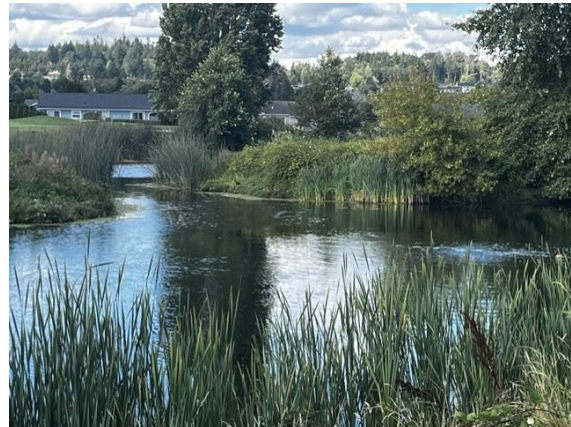
On the left, the typical filamentous algae mats at SE corner. On the right, Pond #5 next section, view from north of the bridge. Aerator is functioning; small amount of algal mats on surface, similar to last month.

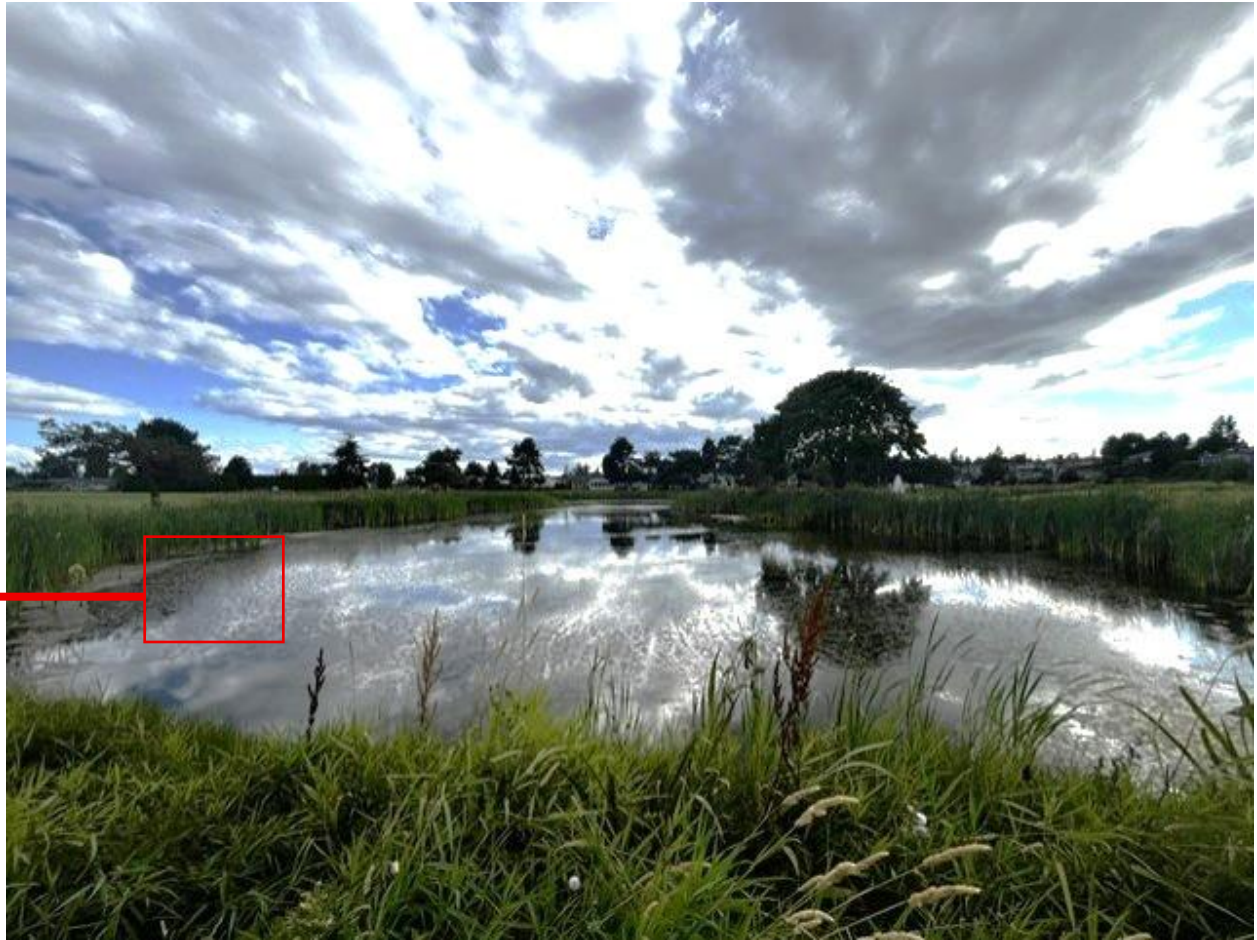
4. **North Golf Course Pond** - 8/1/26. Surface condition: More plant matter on the surface than last month, but apparently not much filamentous algae. Possibly milfoil now appearing here. (see below).

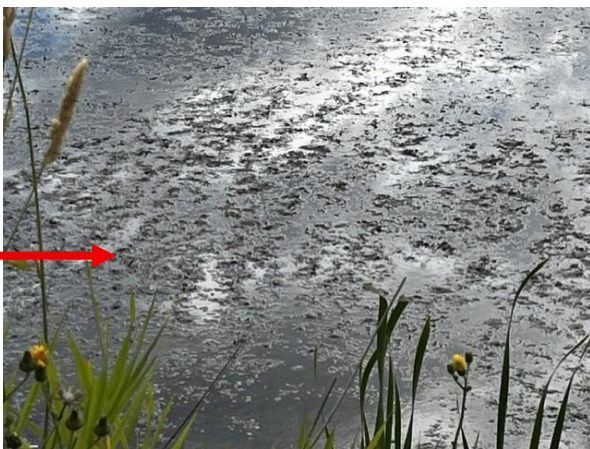
East edge, milfoil appears to be present here.  
(But could be first growth of Azolla). Needs I.D.

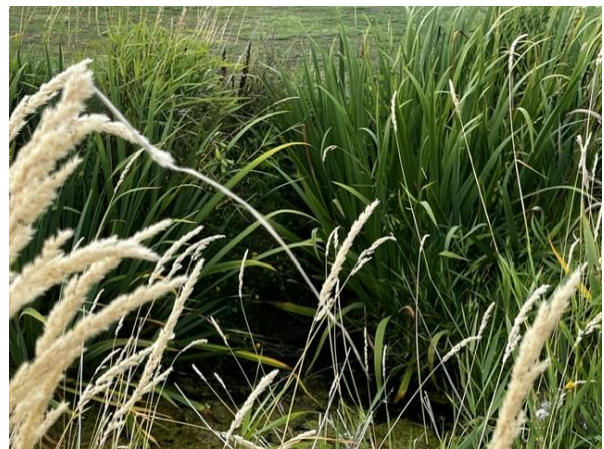
Far N.E. corner (near culvert): less plant debris  
present than last month. Duckweed reduced.

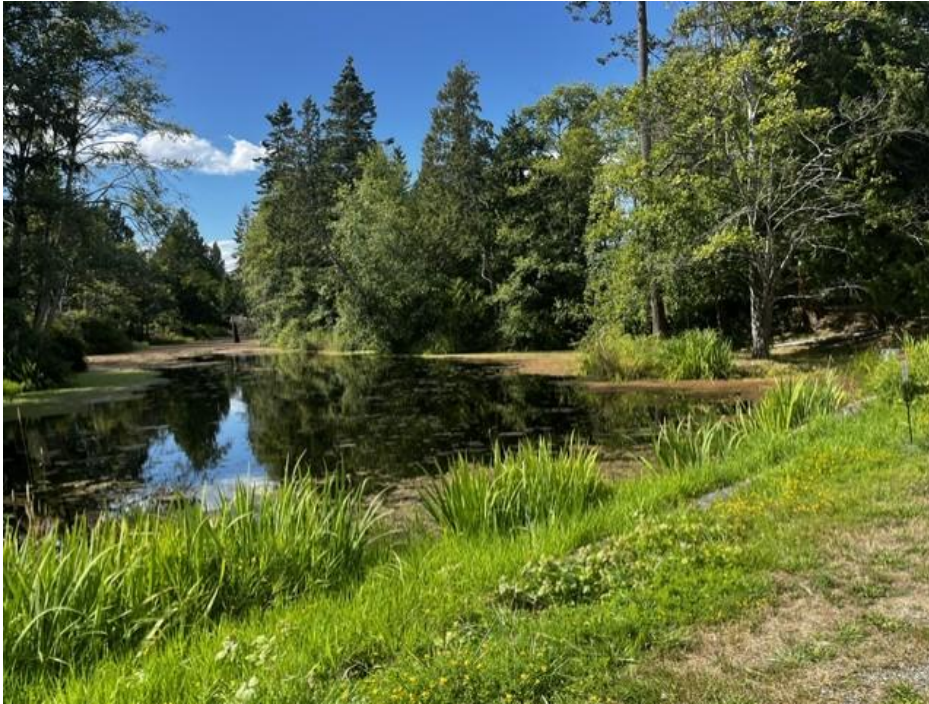
8/1/26- Beaver Pond, lower (south) end, viewed from Chinook Way. Conditions similar to last month; slightly more surface plant growth since July 1<sup>st</sup>. Also, new appearance of a different plant type.

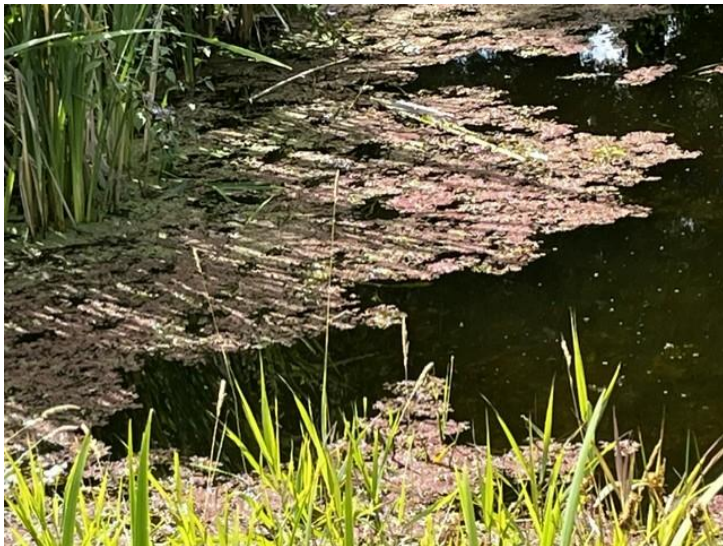
The south end of the Beaver Pond now has a surface plant growing that appears to be similar to that seen on the southwest corner/edge of Thunderbird Lake (it has what seem to be tiny, clustered leaflets and a grey green/rusty-red appearance). At first glance it seems to be a reddish-hued version of duckweed. But that is unlikely. It is possible we are now seeing an appearance in several different water

bodies (including here in the Beaver Pond) of “Azolla”, as seen in the Golf Course Pond #4 and photographed last month by Betsy Just. Here is her early July photo for reference:

A sample could be most readily attained at the south end of the Beaver Pond (from Chinook Way) for positive plant identification.
