SEPTEMBER 2026 MTG. REPORT

**RE: BBV LAKES & POND ALGAE, CURRENT CONDITIONS**

This is the 5th report for 2026, with photos and notes on 6 different water bodies. These include **Thunderbird Lake** SE corner, **Kwann Lake** [NE corner + SE corner] the **South Golf Course Pond #5**, and the **North Golf Course Pond #1**. Also now included are photos and notes from the center (mid-course) golf course pond that was severely impacted with Azolla. The **Beaver Pond** is also now being included.

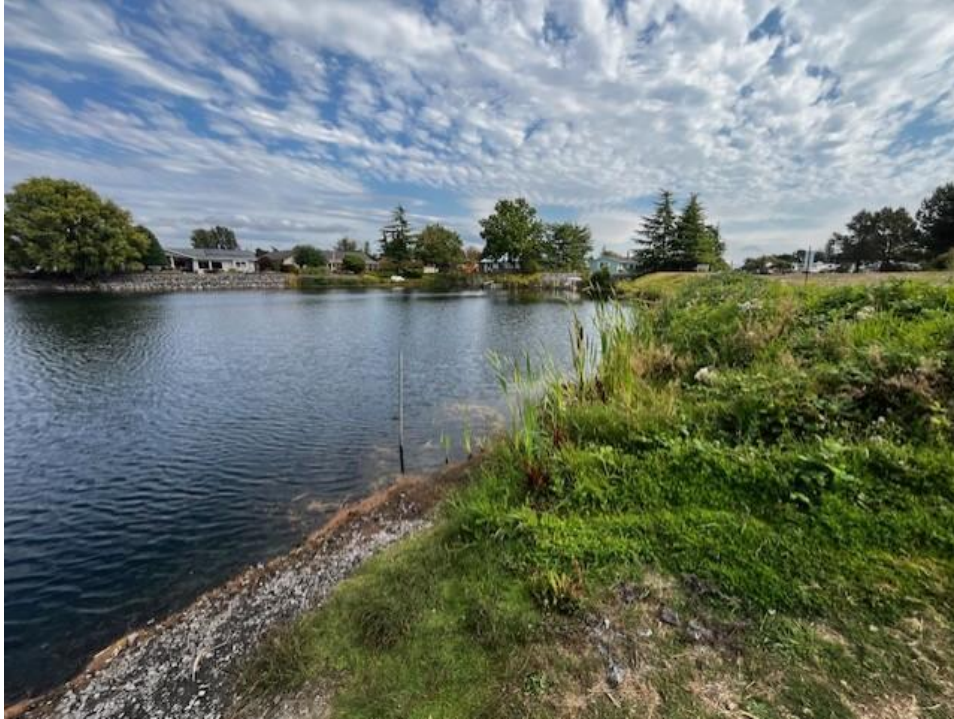
| LOCATION: PHOTOS<br>TAKEN ON 9/01/26 | IS ANY SURFACE<br>ALGAE PRESENT<br>NOW? | DESCRIPTION OF CURRENT CONDITIONS |
|---|---|---|
| 1. Thunderbird Lake,<br>SE corner near boat<br>launch | YES, very small<br>amount | Some very minor signs of e filamentous algae on the edge of the lake, and some remnants of the azolla infestation that appeared last month and was then treated with a de-foliant herbicide. |

1. **SE Corner of Thunderbird Lake, 9/1/26.** Thunderbird Lake water now generally clean and clear after last month's azolla appearance. The lake surface is devoid of filamentous algae as seen from this viewing location. Modest amounts of remnant azolla present near the edges. The shoreline plant growth (including blackberry bushes) along the southern edge is limited.

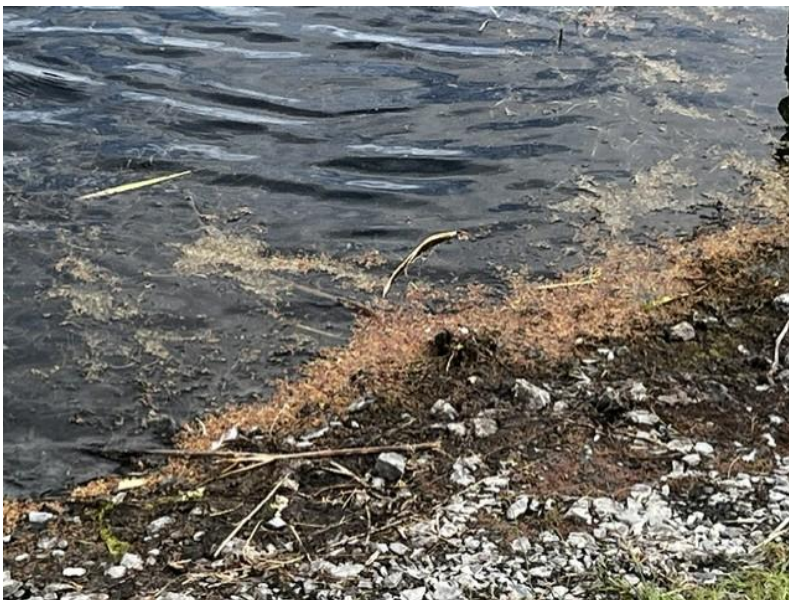
Closeup at this observation point on Thunderbird Lake shows some bottom-growing algae built up, with (dead/dying) remnants of azolla still present on the surface along the edges.

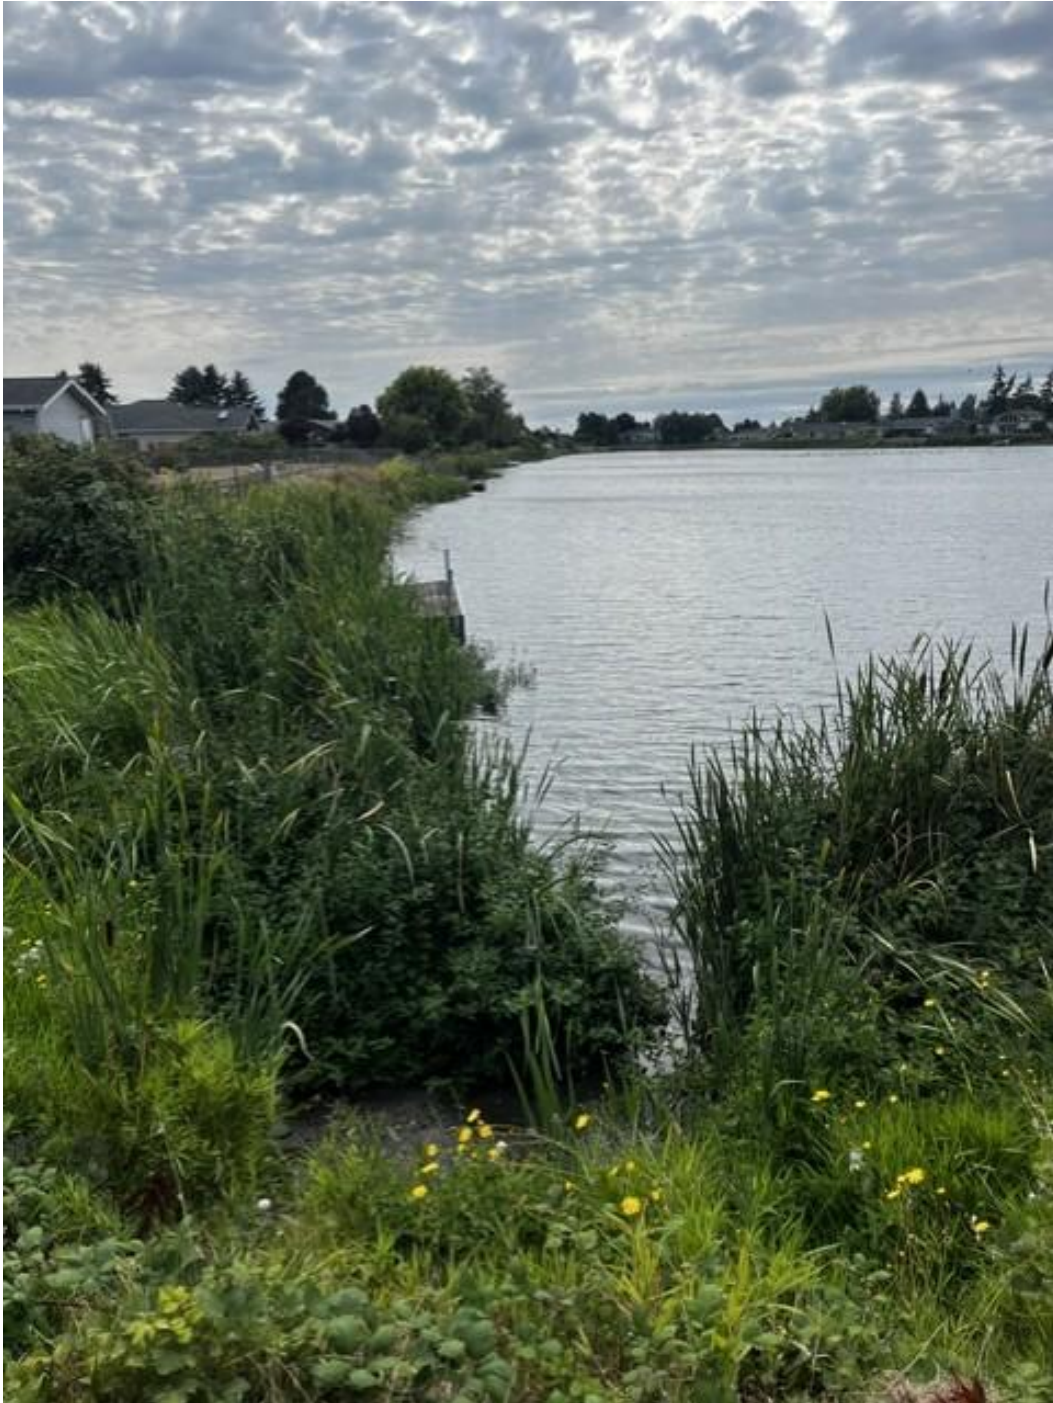
| LOCATION: PHOTOS<br>TAKEN ON 9/01/26 | IS ANY SURFACE<br>ALGAE PRESENT<br>NOW? | DESCRIPTION OF CURRENT CONDITIONS |
|---|---|---|
| 2. Kwann Lake, NE<br>corner near the<br>blocked culvert | NO | No signs of any type of algae are visible on the surface here, but for a few small globs in the far NE corner. |

2. **NE Corner of Kwann Lake, 9/1/26.** No sign of any algae on the surface or along the edge here.

The shoreline-edge plants including canary grass, the usual/typical blackberry bushes, and some cat-tails in this area are robust, down to the water's edge. The proliferation of nightshade at this corner of Kwann Lake, including homeowner lots on the east edge, continues.

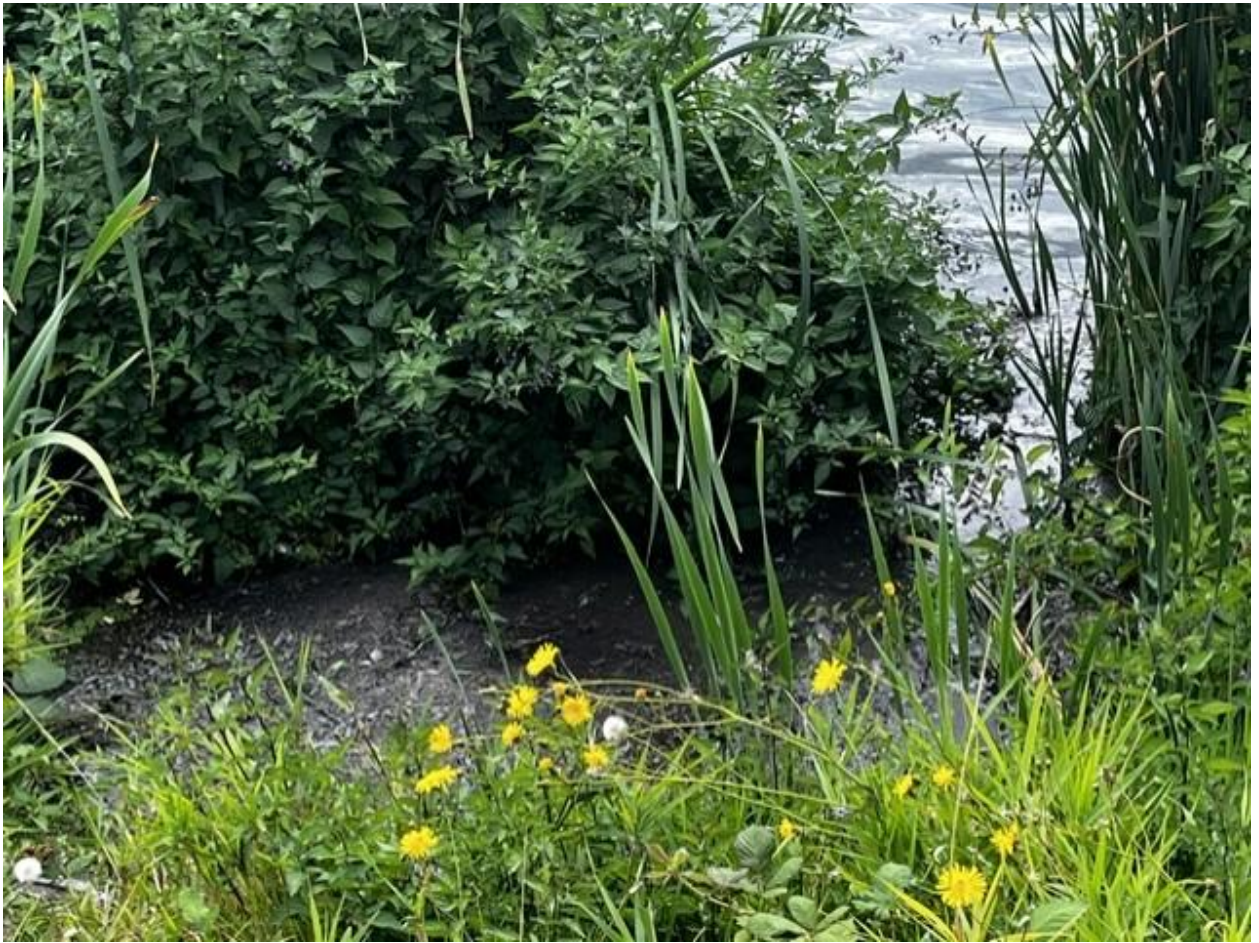
Closeup of this northeast corner of Kwann Lake shows the typical buildup of 'pond scum' on the surface: a mix of dead leaves, pollen, feathers and dust. The recently-cleared areas of the shoreline (to facilitate better access for fisherpersons) are now supporting the growth of wildflowers.

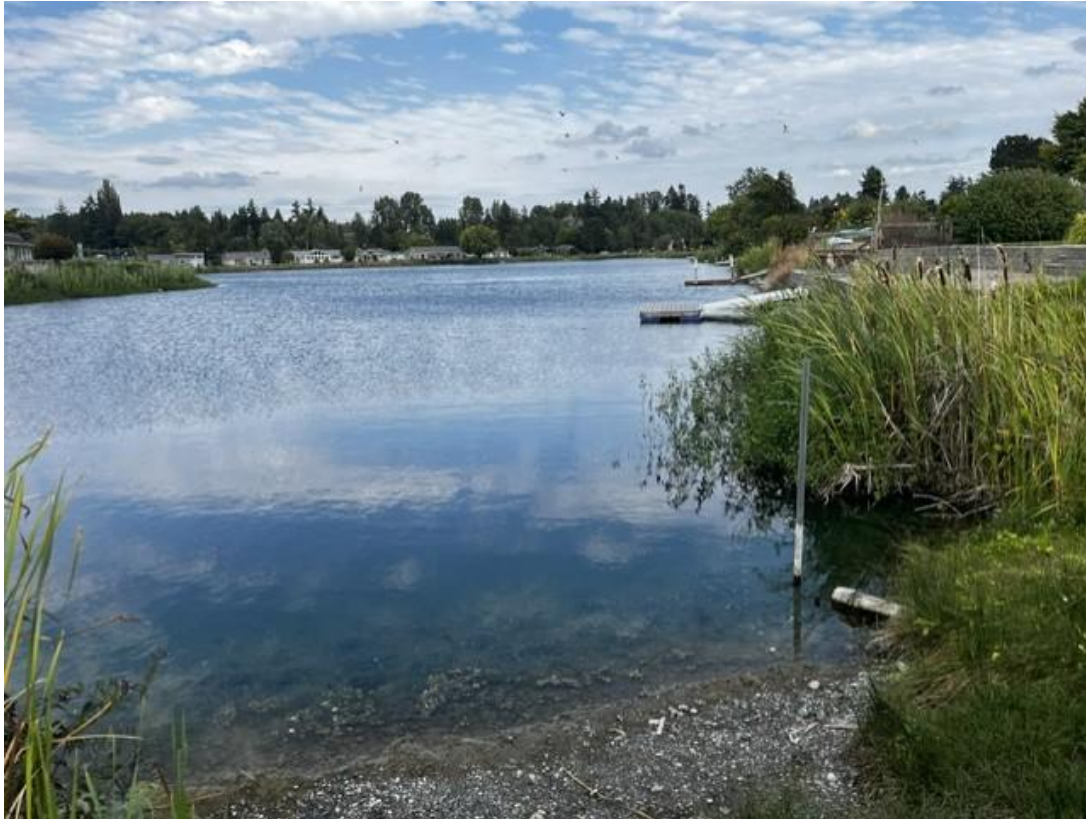
| LOCATION: PHOTOS<br>TAKEN ON 9/01/26 | IS ANY SURFACE<br>ALGAE PRESENT<br>NOW? | DESCRIPTION OF CURRENT CONDITIONS |
|---|---|---|
| 2a. Kwann Lake, SE<br>corner near launch | YES, very small<br>amount | Small bits of visible surface algae and other unknown plant (possibly azolla), in very modest quantities. |

2a. **SE corner of Kwann Lake near boat launch.** 9/1/26. Lake as viewed from here is generally clean and clear. Some very minor signs of bottom-growing algae are present at this location.

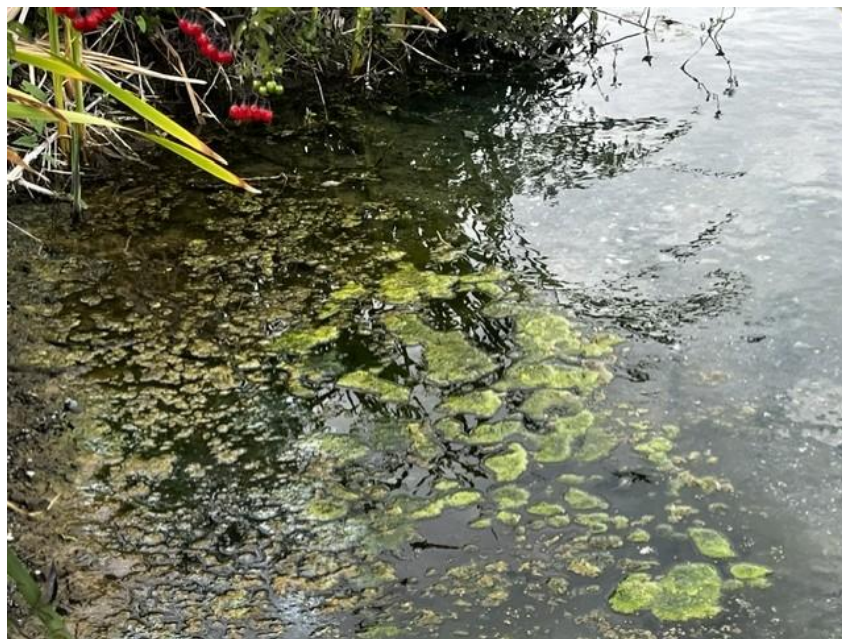
Closeup at this SE Corner (boat launch). Some 'globes' of algae on the surface; also possibly some signs of azolla or another similar aquatic plant now appearing here, which is not typical. This plant material is clustered near the sheltered shoreline, shielded from winds by the nightshade and other edge plants.

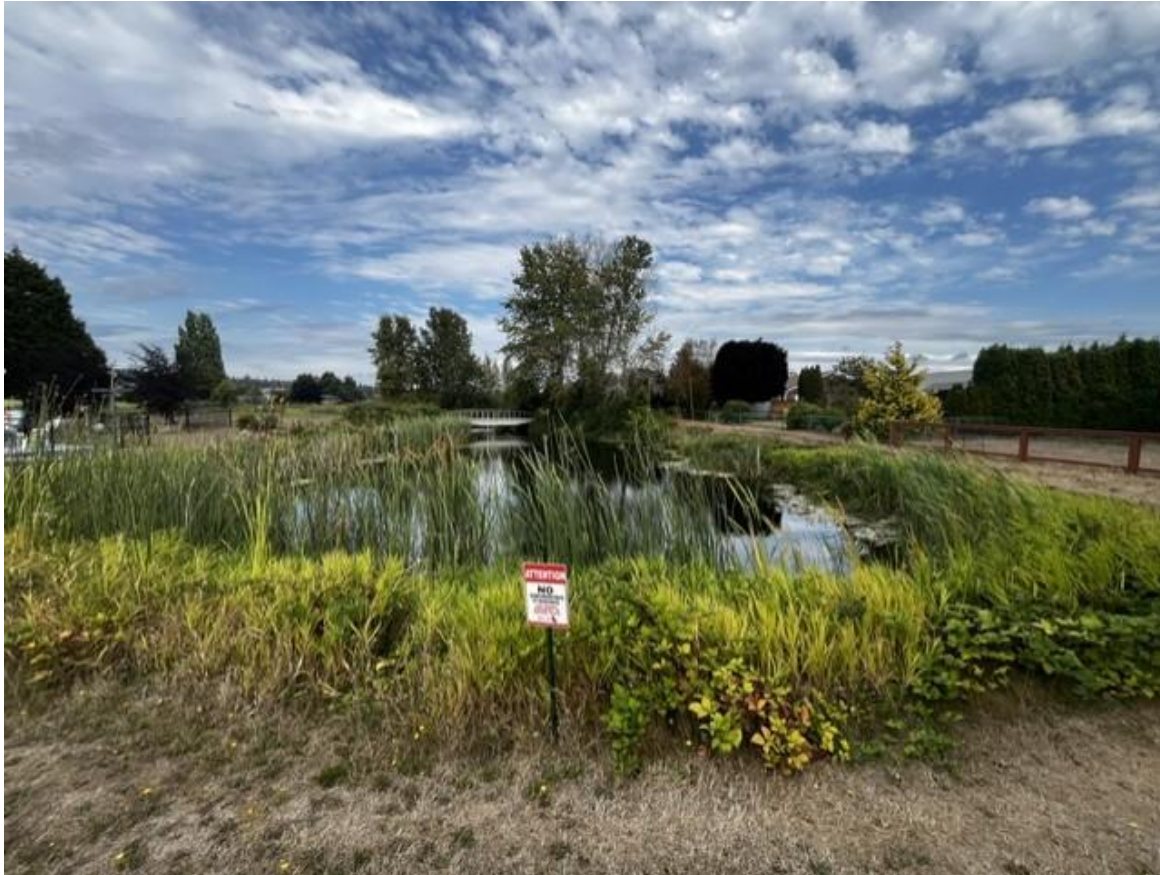
| LOCATION: PHOTOS<br>TAKEN ON 9/01/26 | IS ANY SURFACE<br>ALGAE PRESENT<br>NOW? | DESCRIPTION OF CURRENT CONDITIONS |
|---|---|---|
| 3. South Golf Course<br>Pond (#5), viewed<br>from the road | YES, at edges as<br>usual | Filamentous algae mats are visible as is typical on both eastern and western edges. Amount is reduced compared to last month. |

3. **South Golf Course Pond (#5)** –9/1/26. Filamentous algae still appearing on the surface at both the eastern and western shoreline edges (minor amounts). Plants at the edge growing robustly.
- 4.

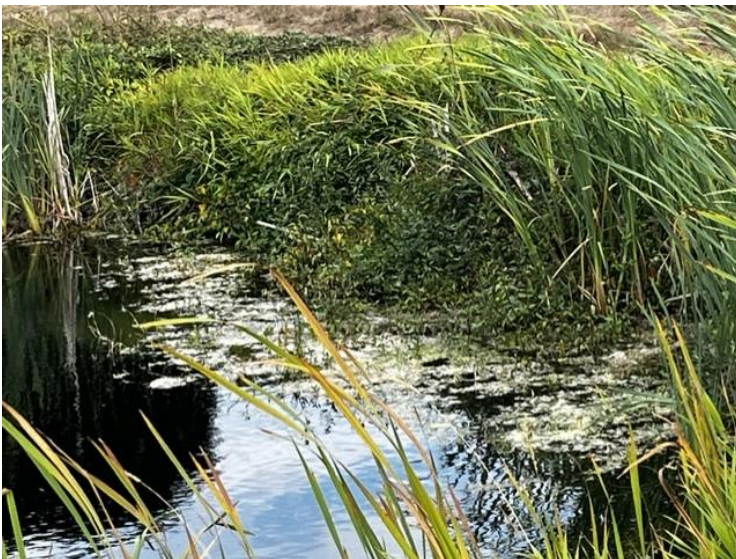
The typical filamentous algae mats can be seen at this SE corner. Slightly reduced amount compared to last month.

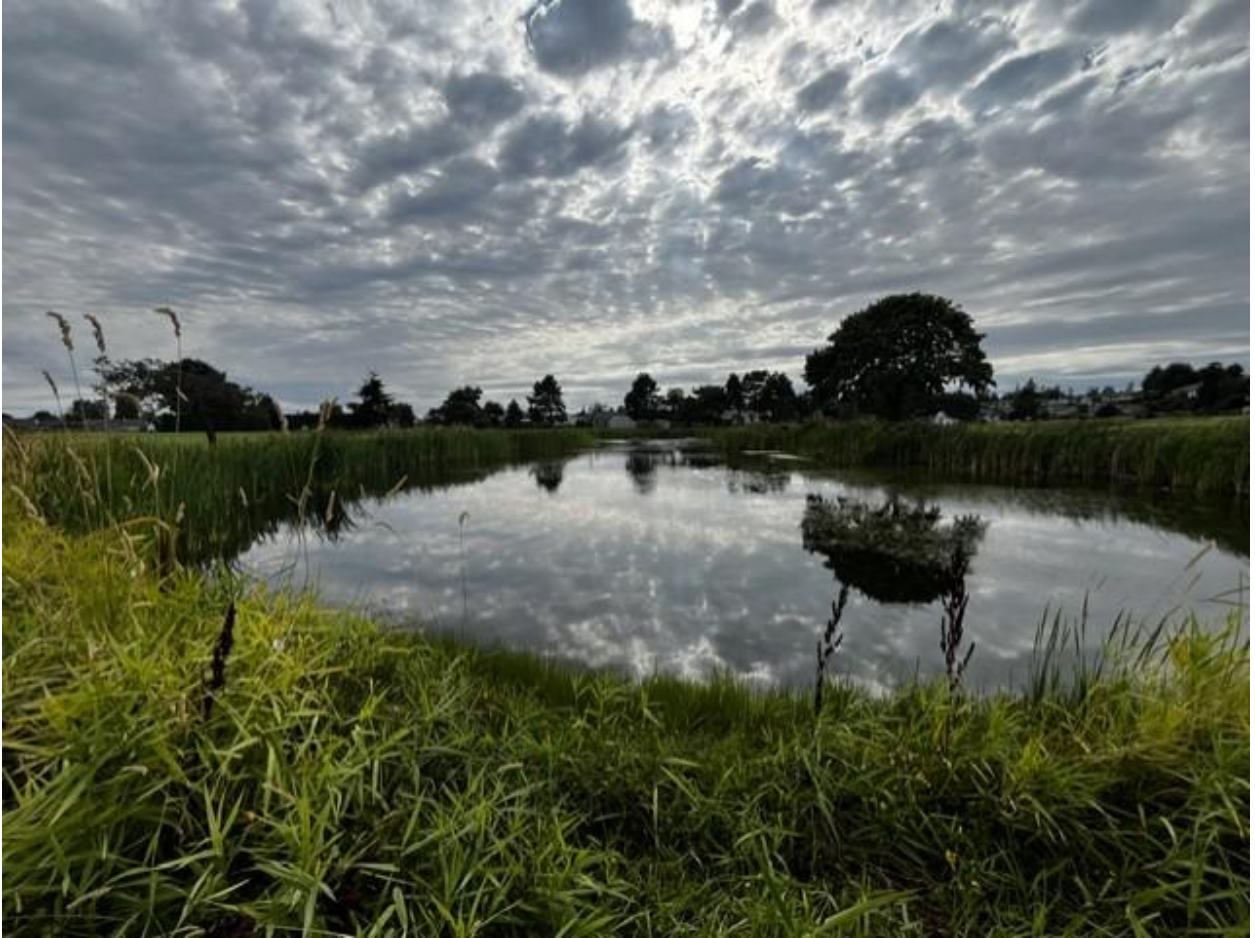
| LOCATION: PHOTOS<br>TAKEN ON 9/01/26 | IS ANY SURFACE<br>ALGAE PRESENT<br>NOW? | DESCRIPTION OF CURRENT CONDITIONS |
|---|---|---|
| 4. North Golf Course<br>Pond (#1), viewed<br>from east shoreline | NO | No shoreline-edge filamentous algae mats are now present. There are some signs of another aquatic plant (most likely Eurasian milfoil) on the surface, but much less than earlier in the summer. |

5. **North Golf Course Pond** - 9/1/26. Surface condition: Much less plant matter on the surface than last month; no longer any signs of filamentous algae. Possibly milfoil now appearing here. (see below).

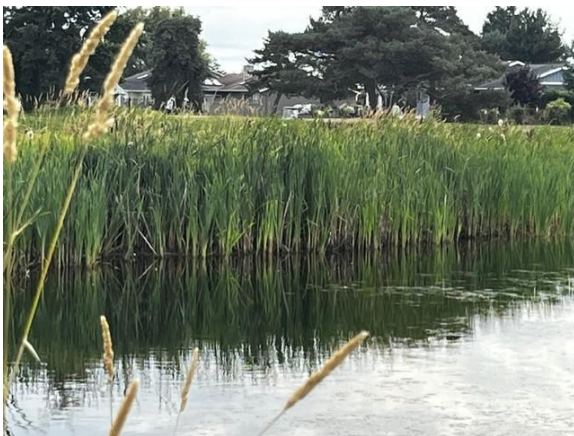
East edge: algae is gone. A small amount of milfoil appears to be present here.

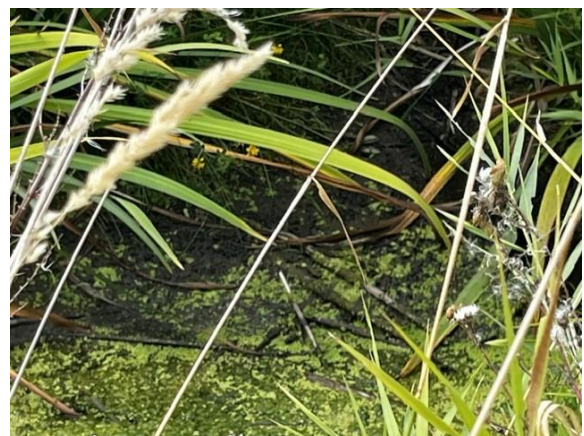
Far N.E. corner (at culvert): typical scum buildup. Duckweed present here, as usual.

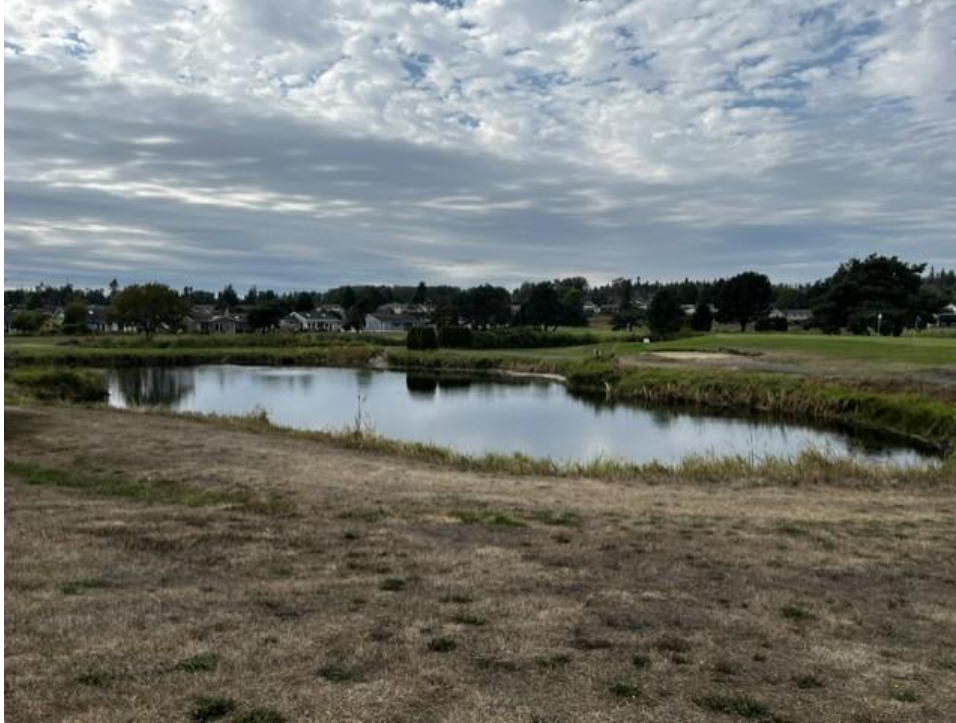
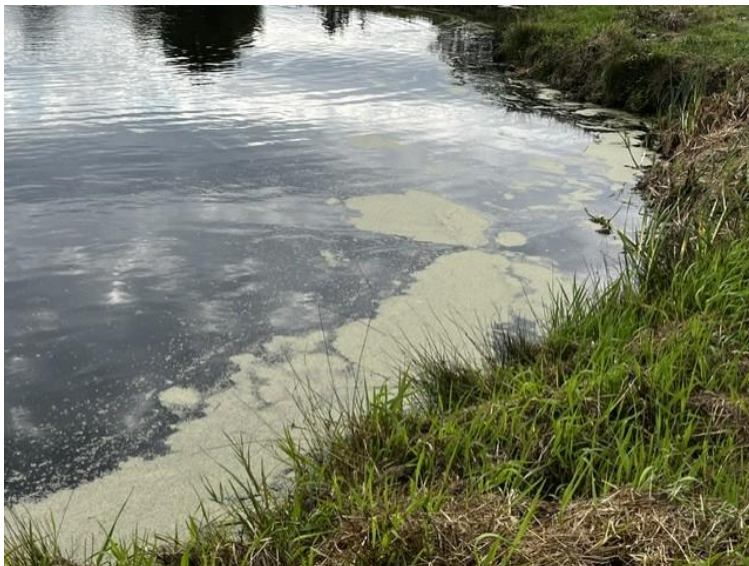
### 5. Center Golf Course Pond (#3)

| LOCATION: PHOTOS<br>TAKEN ON 9/01/26 | IS ANY SURFACE<br>ALGAE PRESENT<br>NOW? | DESCRIPTION OF CURRENT CONDITIONS |
|---|---|---|
| 5. Center golf course<br>pond (#3) | NO, but azolla<br>remnants are<br>present | The azolla removal activity appears to have been successful. Some small amounts remain; no signs of algae however. |

This was the site of a massive Azolla buildup which began in early June. The mechanical-harvesting intervention during August was a successful action that had a positive effect. Maintenance also did a significant trimming of shoreline plants here, making the entire edge of the pond more accessible.

While there are a few remnant signs of azolla along the edges (as above), the massive infestation appears to have been mitigated. As temperatures cool, and if windy conditions continue, it is unlikely the azolla will thrive again here this season.

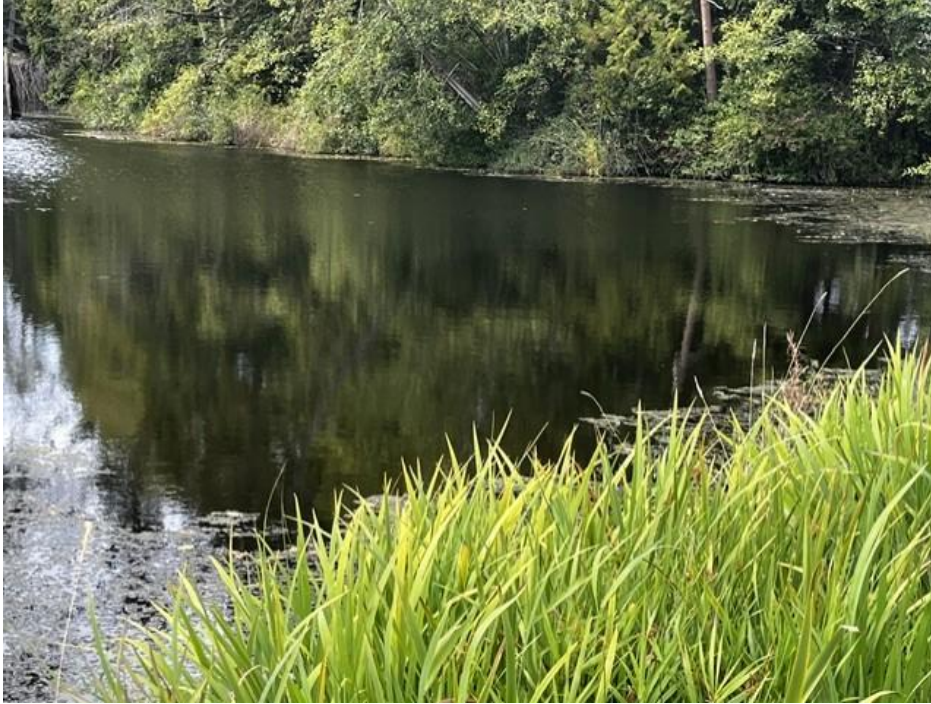
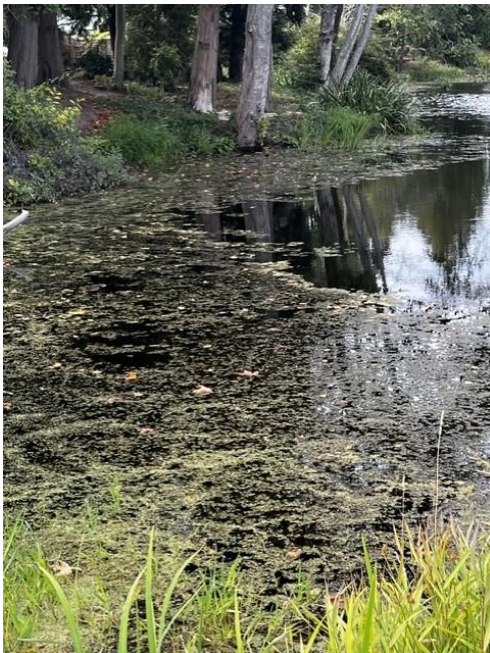
| LOCATION: PHOTOS<br>TAKEN ON 9/01/26 | IS ANY SURFACE<br>ALGAE PRESENT<br>NOW? | DESCRIPTION OF CURRENT CONDITIONS |
|---|---|---|
| 6. Beaver Pond | YES, along with<br>some azolla<br>remnants | Natural, unmaintained conditions. Riparian area, mature tree growth overhanging the water area on both sides. Algae and other aquatic plant growth on surface. |

**6. Beaver Pond – 9/1/26** - This water body is one of the only locations in Birch Bay Village still presenting as a natural, unaltered riparian zone. It is not managed by BBV Maintenance, and there is no attempt to control algae. The aggressive growth of azolla that was present last month is mostly self-resolved.

The aggressive growth of azolla that was present at this southern edge of the Beaver Pond last month is much sparser. Some remnants are visible. but the tight-packed mats are much less thick now.

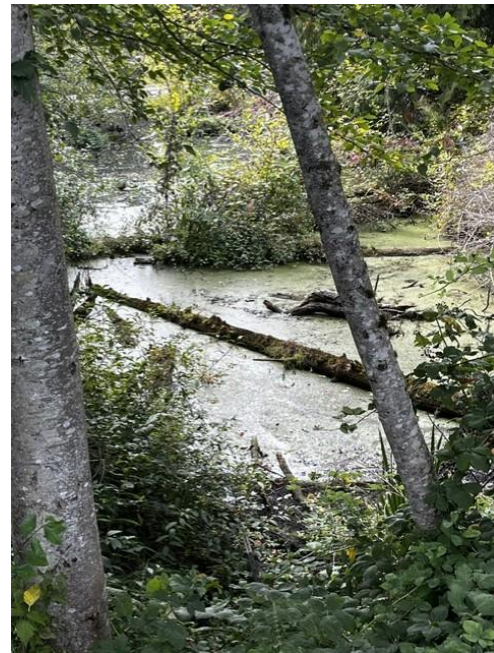
At the upper reaches of Beaver "Creek", the natural water body is filled with surface algae, fallen tree limbs, and in-stream shrub growth.

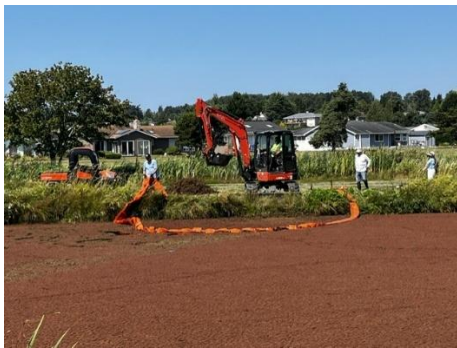
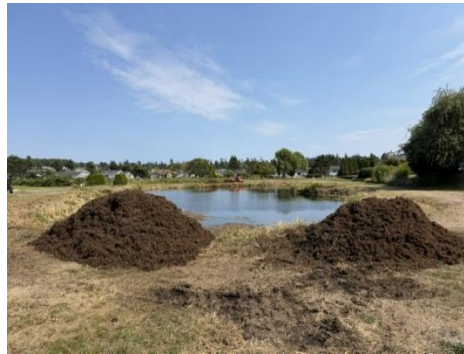
1. Consider determining a way to reduce the large Azolla mat in *Golf Pond #3*: could cause a fish kill due to oxygen level reductions.

*Action: mechanical harvesting and labor-intensive intervention removed about 10 tons of azolla. See photos below: before, and after.*

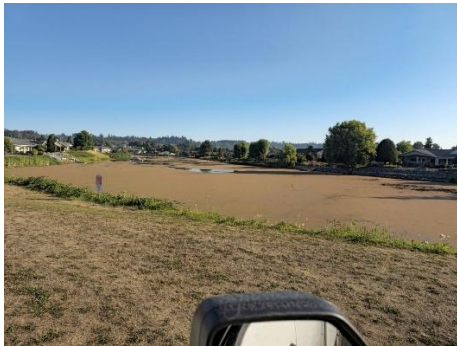
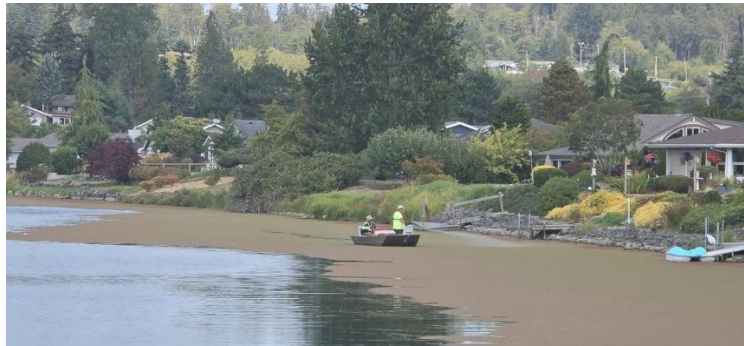
2. Closely watch what is possibly Azolla growing on the west edge at the south end of Thunderbird.

*Action: the azolla did spread rapidly; a quick response by Maintenance with a defoliate herbicide, surface-applied by boat, helped resolve the issue. See photos below: infestation, and defoliate action.*
